Damage Survey of the Violent Tornado in Southeast Czechia on 24 June 2021

Tomáš Púčik
David Rýva
Miroslav Šinger
Miloslav Staněk
Pieter Groenemeijer

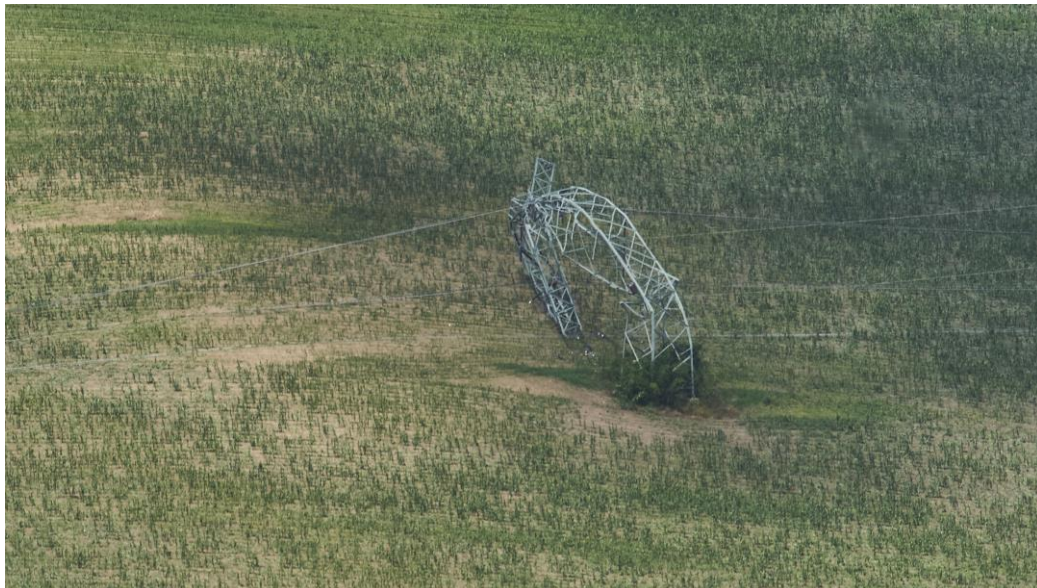
The tornado was the widest at the very beginning of its track. The damage swath east of Břeclav was measured to be up to 2.8 km wide. The tornado quickly became strong, bringing down multiple high-voltage power line pylons and snapping trees. The ground survey noted an impact of vehicles that had been pushed sideways by the tornado onto safety barriers, resulting in IF2 damage. The first IF3 rating was given to a segment of a tree alley to the east of the highway where trees were fully debranched. The tornado then crossed the railway and impacted a small industrial complex significantly damaging two brick buildings that were rated IF2. The railroad catenary was also damaged by the tornado.

Destroyed pylon of 400 kV power lines. Photo: Lukáš Ronge

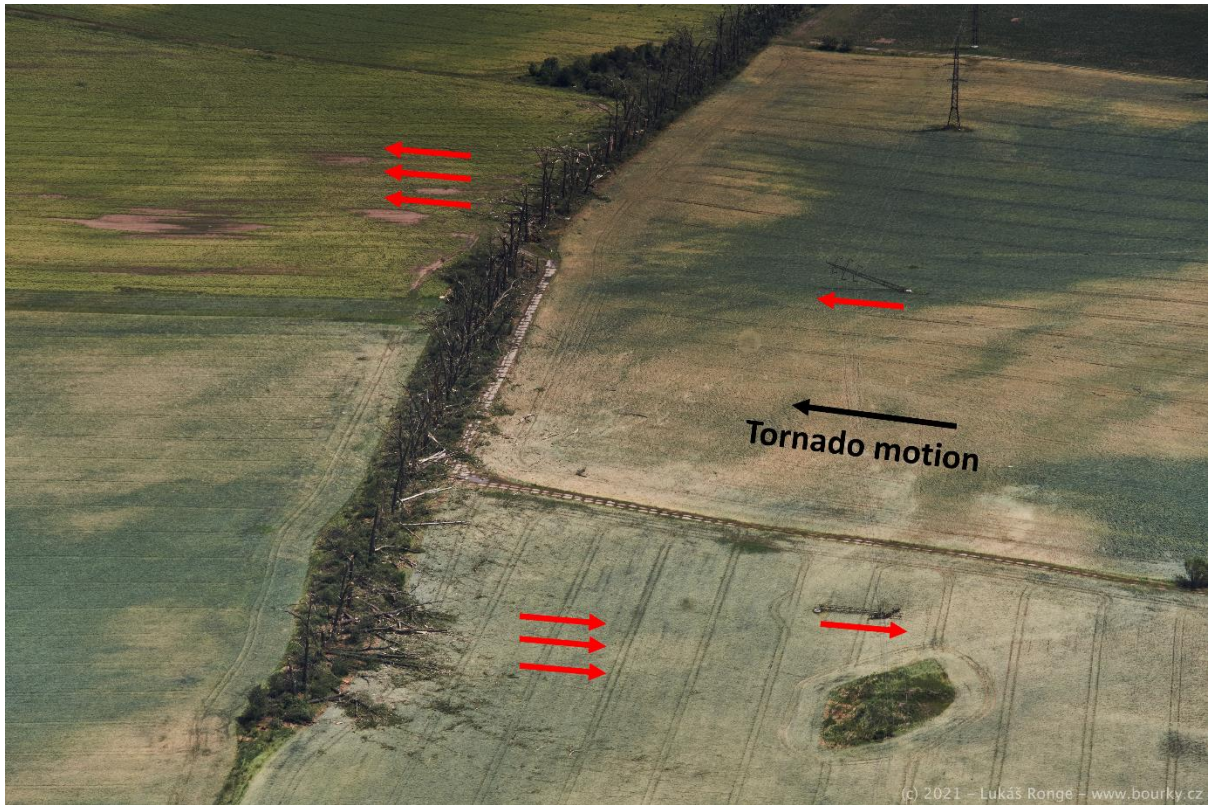
Damage to the tree stand and power line pylons. Note the difference in the fall direction of trees and the masts. Photo: Lukáš Ronge

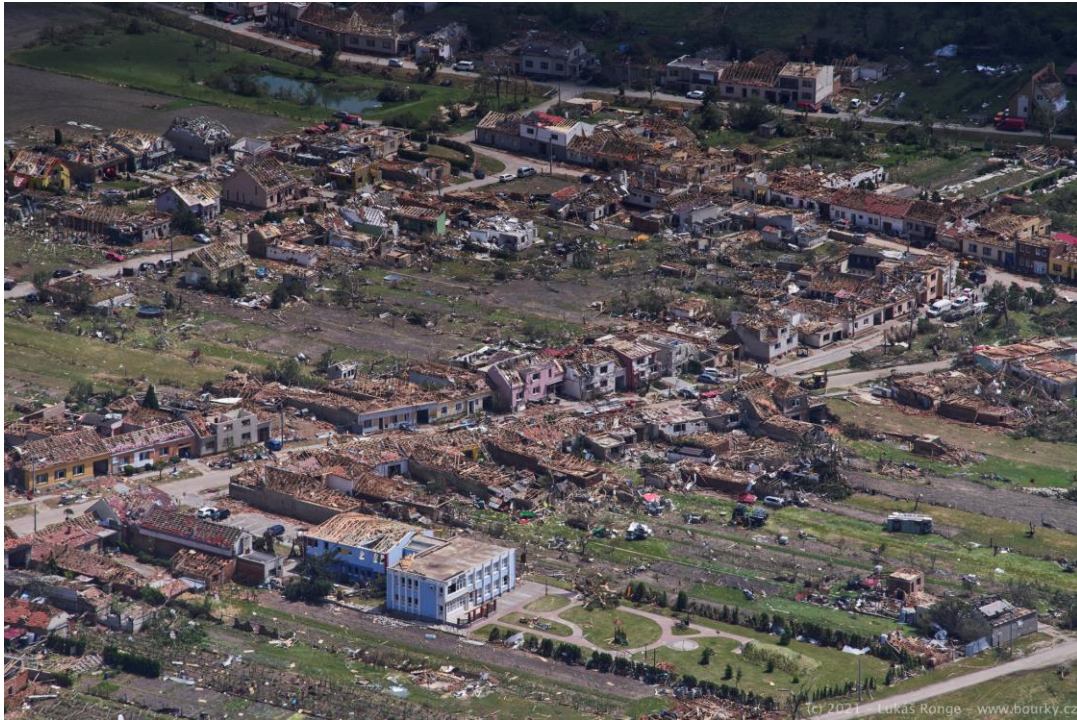
The most common observed damage in Hrušky was partly or completely destroyed roofs. In addition, weaker brick walls of some houses were heavily damaged or destroyed. A church tower at the edge of the swath of the IF2 winds had partly collapsed. Numerous outbuildings were completely destroyed. A caravan weighing 7 tonnes was lifted and landed 20 meters away, flying over a garage of a house. Two fair attractions weighing several tonnes were also lifted and tossed several meters away from their original location. Several cars were found to be thrown against the walls of houses or into gardens. A large metal container was found wrapped around the iron pole of a gate. The highest damage rating assigned in Hrušky was **IF3**.

Aerial photo of significant damage in Hrušky. Photo: Lukáš Ronge

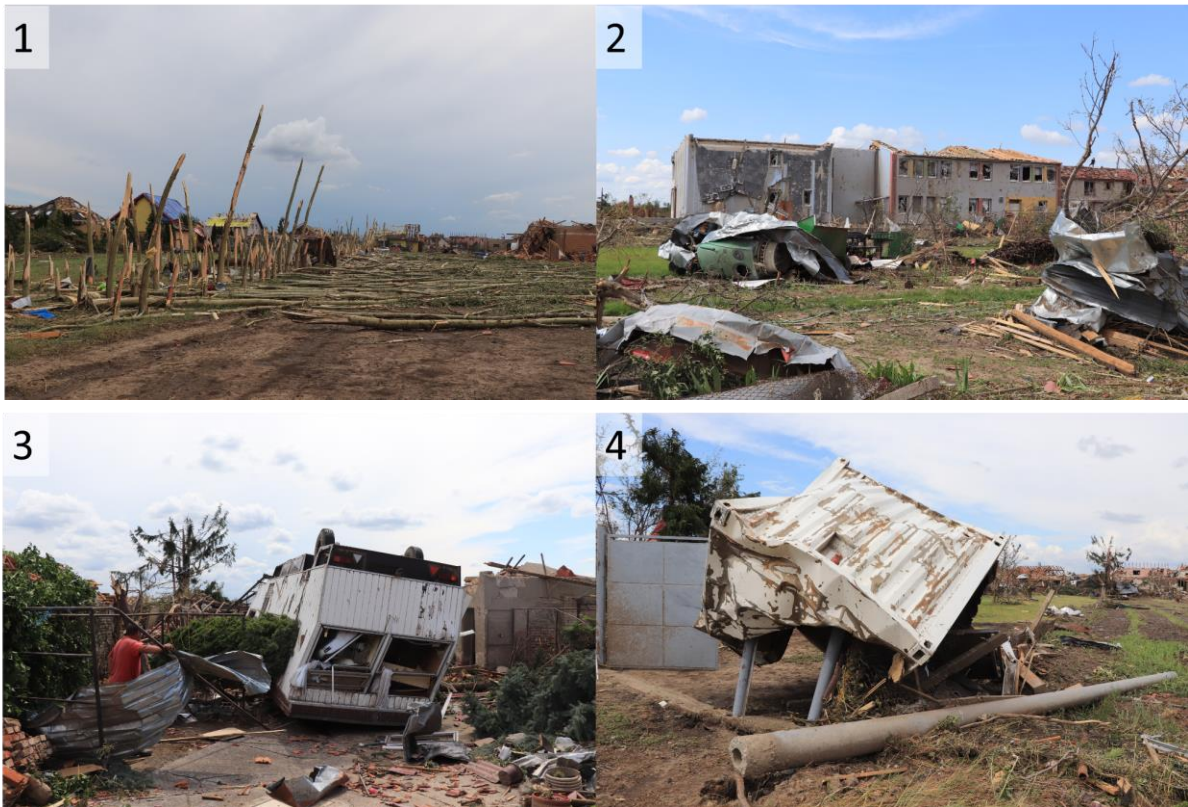
Photos showing damage found in Hrušky. The numbers correspond to the numbers on the map that indicate the location where it was taken. The locations of photos 1 - 4 can be found on the map of Hrušky below. Photos: Tomáš Půčík.

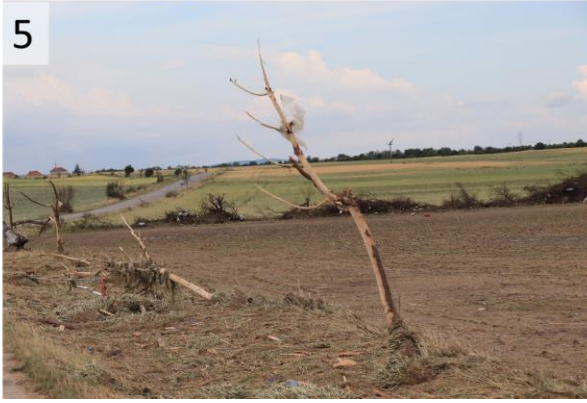
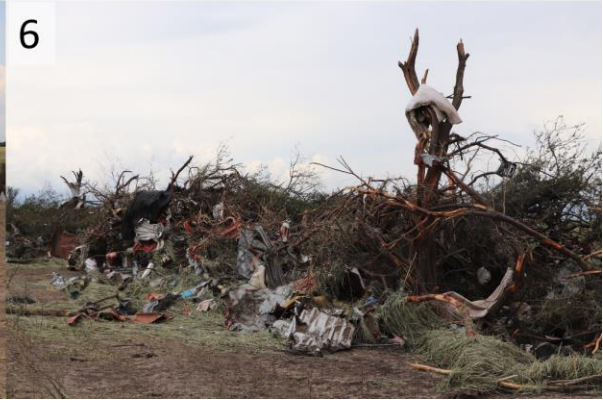
Between Hrušky and Moravská Nová Ves, the tornado crossed fields and a road and impacted a tree alley before moving through an agricultural complex with cattle. Grass and crops from the fields were plucked out by the tornado and deposited, along with debris from houses, on the damaged tree alley which was completely destroyed. Several isolated trees ahead of the alley were debranched and almost completely debarked, suggesting violent, **IF4** winds occurred at this stage. Most of the buildings in the agricultural complex were heavily damaged and included the collapse of load-bearing brick walls. A concrete wall of the cattle pen collapsed, killing tens of cows. Due to the weakened structural integrity of the investigated collapsed walls, the highest assigned rating in the complex was **IF3**. Several heavy trailers and tractors as well as large concrete blocks from a hay storing structure were lifted and thrown by the tornado.

Photos showing damage to vegetation between Hrušky and Moravská Nová Ves. The locations of photos 5 - 6 can be found on the map of Hrušky. Photos: Tomáš Púčik.

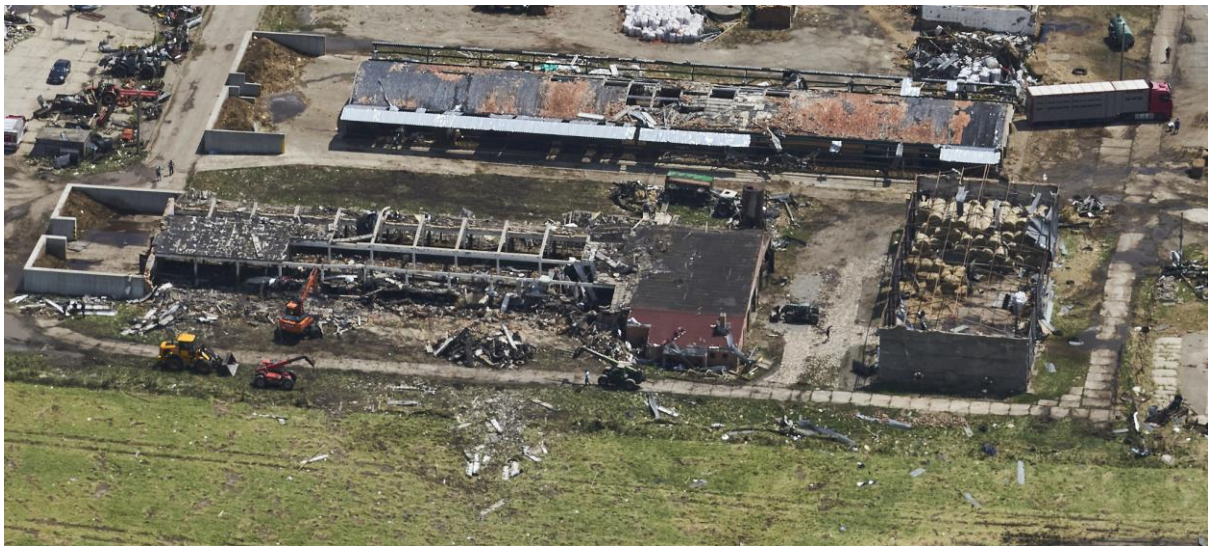
Aerial photo showing significant damage to the cattle pen with the collapse of some of the concrete walls. Photo: Lukáš Ronge

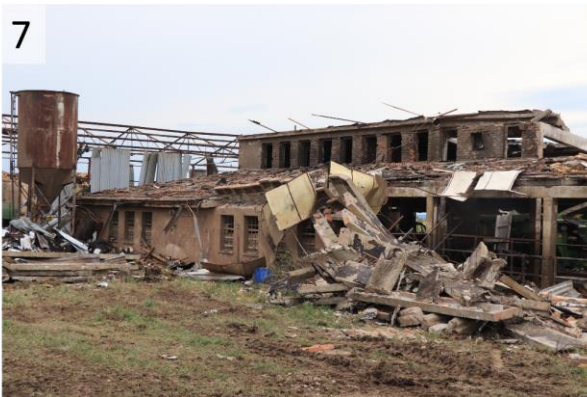
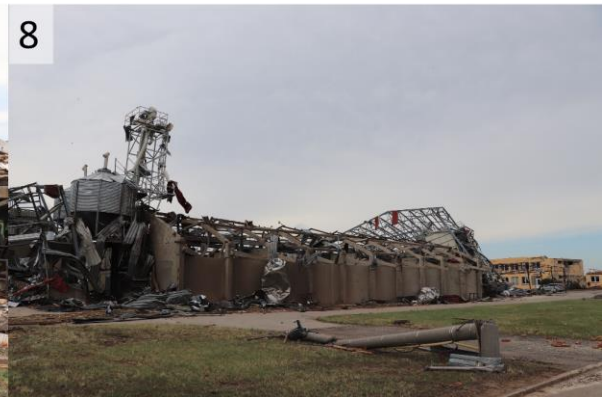
Photos showing damage to the agricultural complex between Hrušky and Moravská Nová Ves. The locations of photos 7 - 8 can be found on the map of Moravská Nová Ves. Photos: Tomáš Púčik.

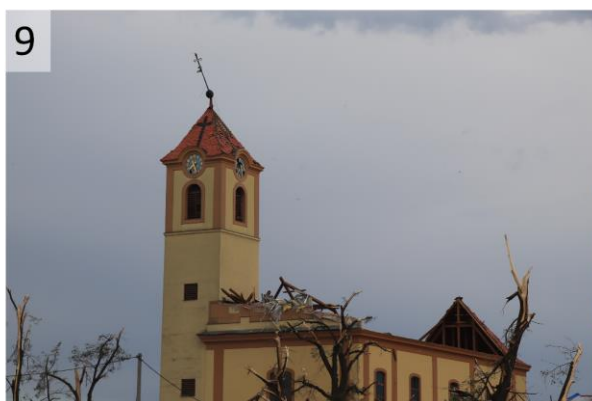
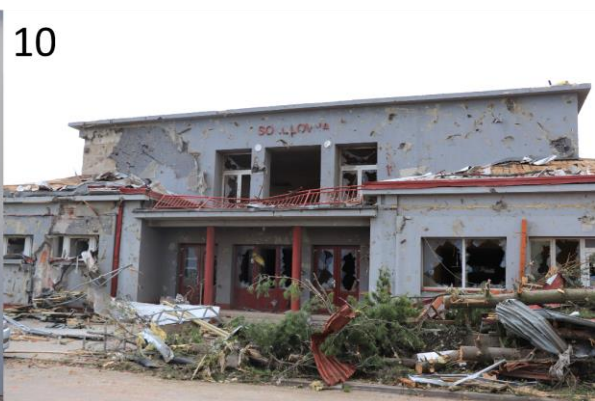
In this village, the highest number of buildings of any village, 369, was damaged. 31 of these had to be demolished, which is a lower fraction than in Hrušky. The tornado was still very wide when crossing the village, with an estimated width of almost 1200 m inferred from the cross-section. The most typical damage observed in the village was the removal of tiles from the roofs. In the central part of the tornado, more significant damage was observed. The widest span of IF2 and stronger winds was almost 500 m, similar to that in Hrušky. Within this swath, the roofs of some of the buildings were completely destroyed, trees debranched, and cars overturned. A truck was overturned at the town square. One of the more notable damage points was significant damage to the roof of the church. The church clocks stopped working at the time of the tornado, showing the time of the tornado: 7:25 p.m. local time. Isolated spots of **IF3** damage were identified in Moravská Nová Ves with damage to the brick walls of the houses. A complete collapse of load-bearing walls was noted with new buildings on the eastern edge of the village. Because the structures were either not entirely finished, or used rather light wall material and weak support between the walls and the ceiling, an IF4 rating was not warranted.

Photos showing damage in Moravská Nová Ves. The locations of photos 9 - 10 can be found on the map of Hrušky. Photos: Tomáš Púčik.

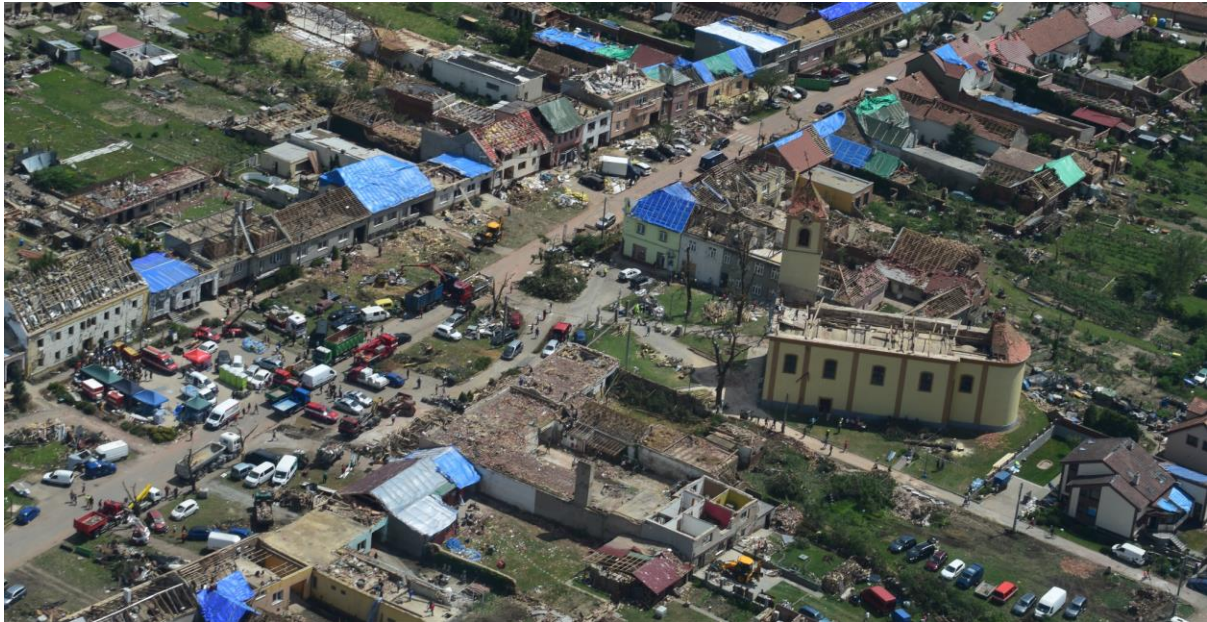
Aerial photo showing damage to the central part of Moravská Nová Ves. Photo: Miloslav Staněk.

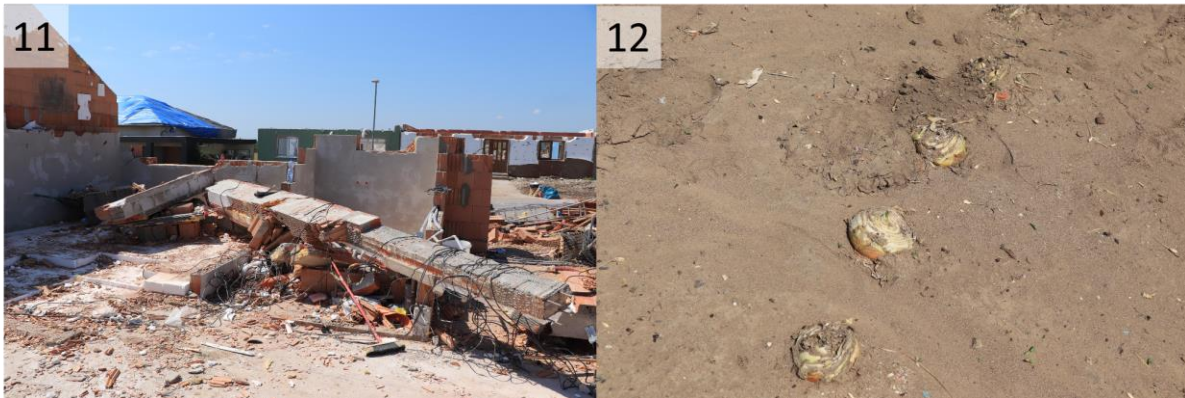
The tornado got narrower, but also more intense as it traveled from Moravská Nová Ves to Mikulčice. 300 houses were damaged by the tornado in Mikulčice, out of which 62 had to be demolished. Three locations with **IF4** damage were observed there. The tornado first impacted a row of newly built houses. Here, an IF4 rating was assigned to the damage of three well-built brick structures. One of the brick structures was completely destroyed, which would warrant an IF5 rating. However, a rather weak connection between the roof and the walls was found, which prevented the damage to be assigned an IF5 rating. Another structure that was completely destroyed was still under construction. Debris from the houses were carried over the following field along considerable distances. Both tree debarking and the removal of topsoil was noted in the field.

Photos showing damage in the western part of Mikulčice. The locations of photos 11 - 12 can be found on the map of Mikulčice. Photos: Tomáš Půčík.

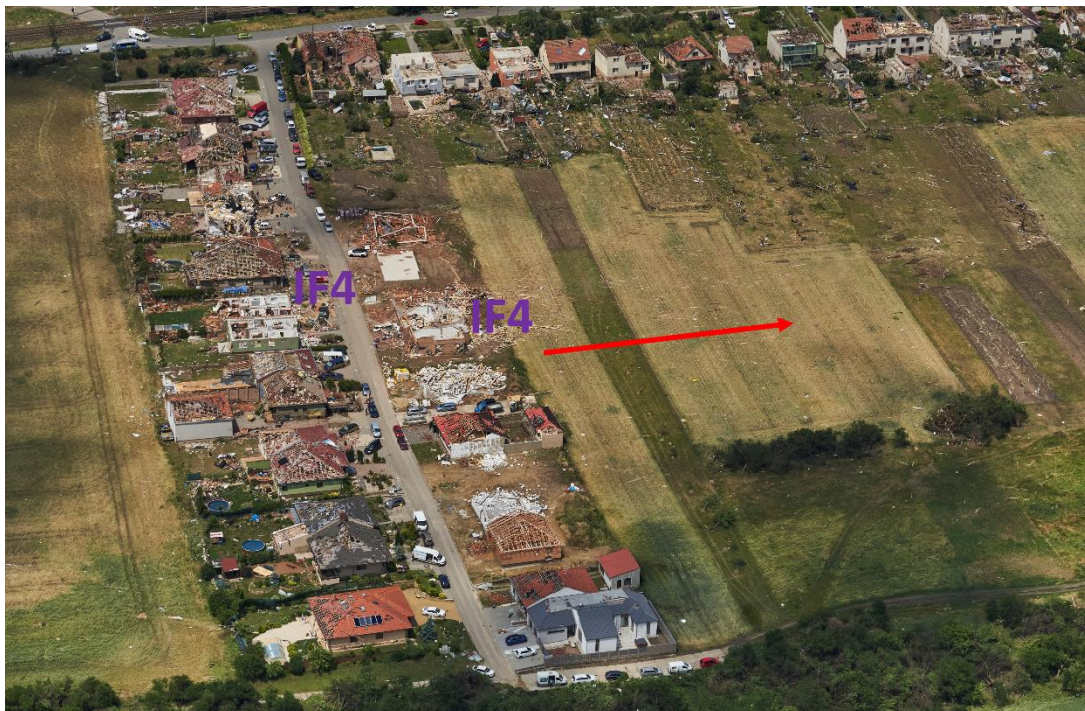
Aerial photo showing the location of IF4-rated houses in western Mikulčice and the direction of debris fall. Photo: Lukáš Ronge.

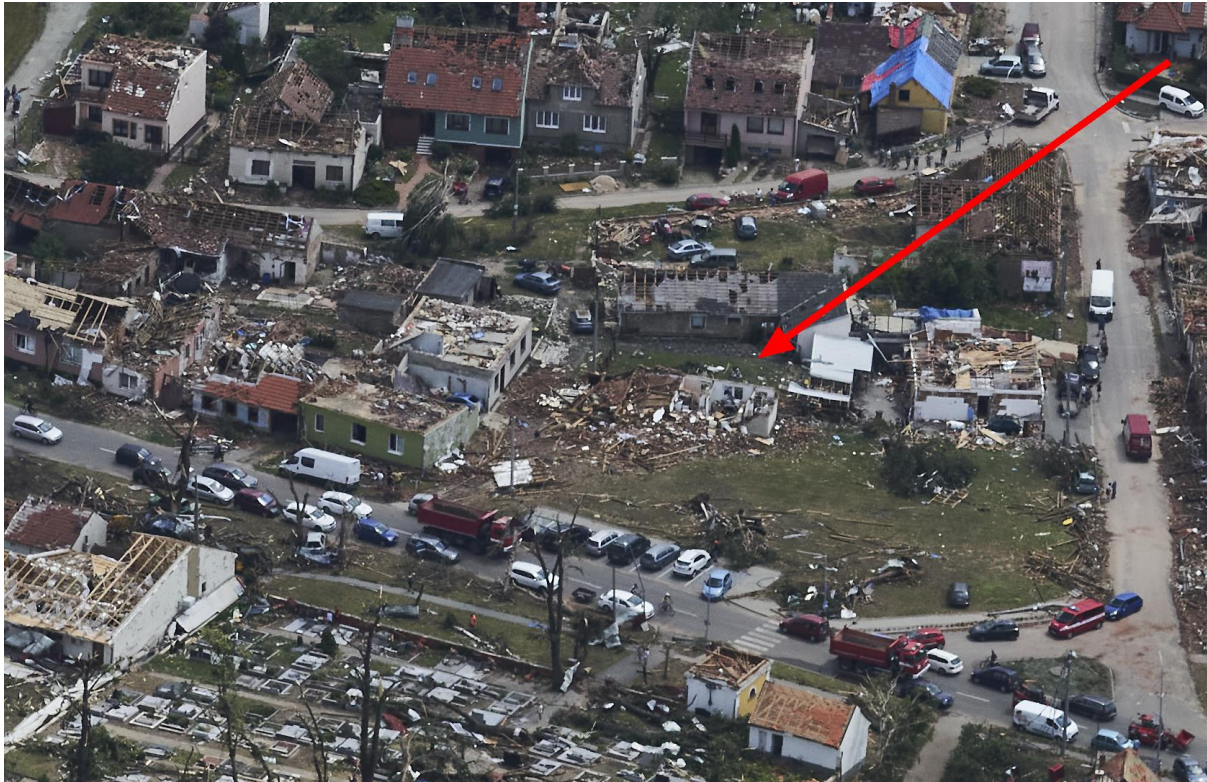
As the tornado moved through the village, numerous houses were damaged or destroyed along the main street and central part of the village with IF2 - IF4 ratings. The most typical damage was the destruction of roofs and collapse of the ceilings, but significant damage to brick load-bearing walls was also noted in some houses. Where the most severe damage occurred, trees were uprooted, snapped, or significantly debranched. Many damaged or destroyed cars were found, but most of them had already been moved from their original locations after the tornado impact. The damage swath was 600 m wide with the swath of IF2 and higher intensity being approximately 200 m wide.

Aerial photo showing the location of an IF4-rated structure in central Mikulčice with a debris fall in the direction of tornado motion. Photo: Lukáš Ronge.

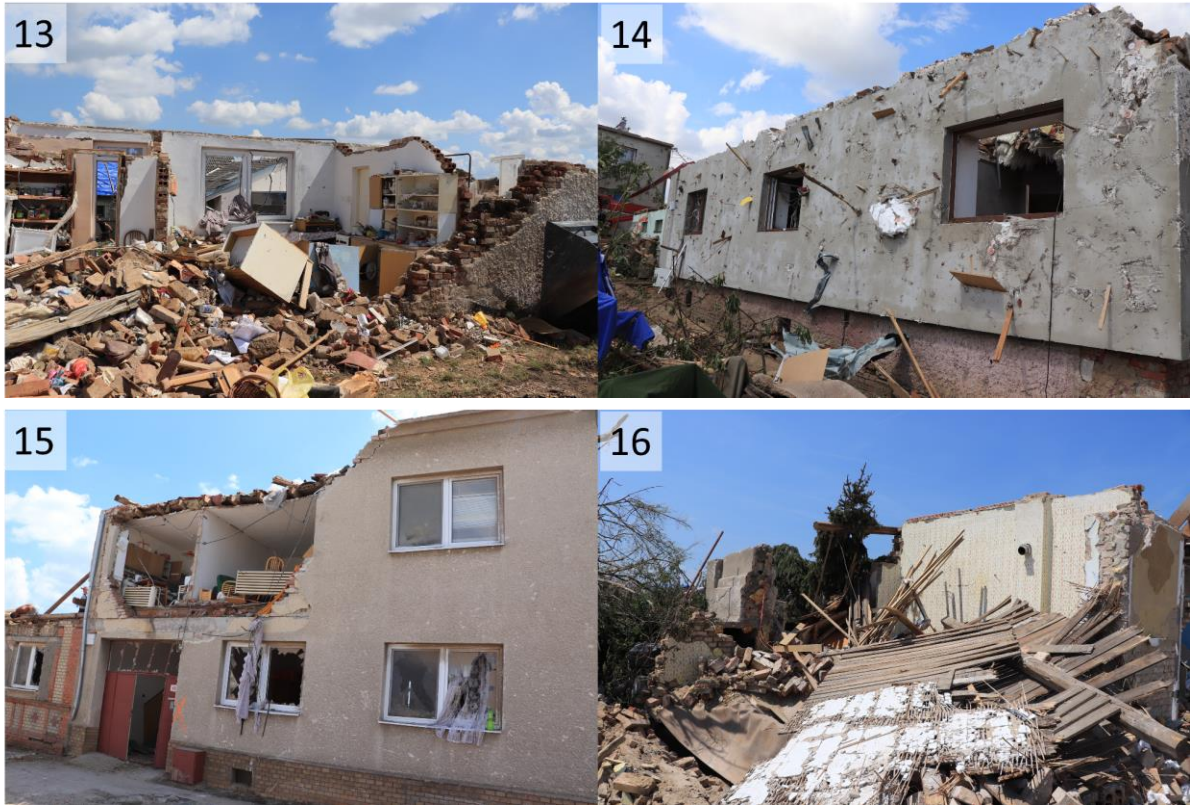
Photos showing damage in the central part of Mikulčice. The locations of photos 13 - 16 can be found on the map of Mikulčice. Photos: Tomáš Půčík.

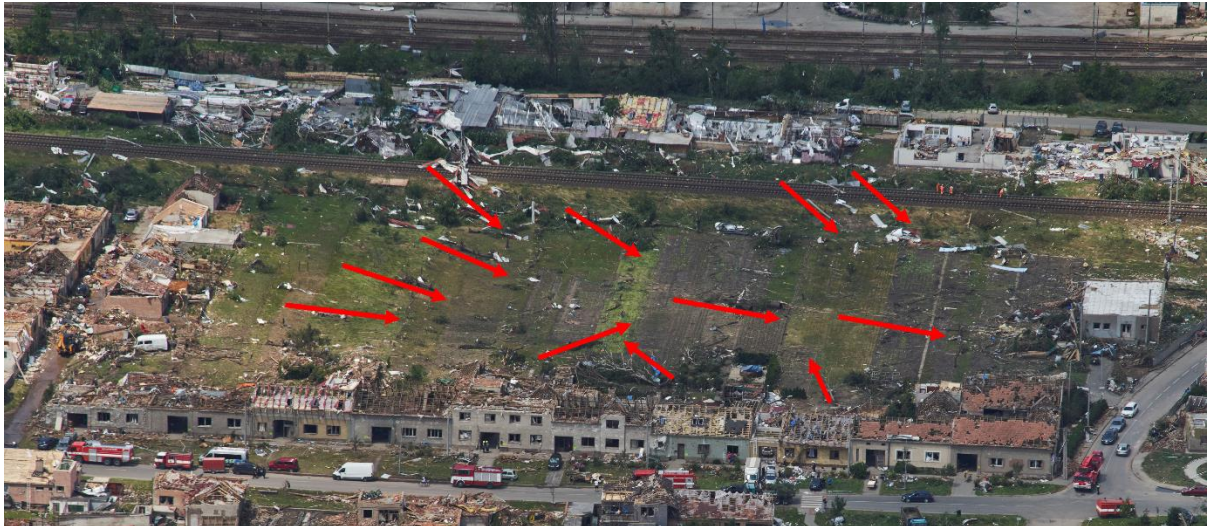
Aerial photo showing convergent debris patterns near the center of the tornado track in Mikulčice. Photo: Lukáš Ronge.

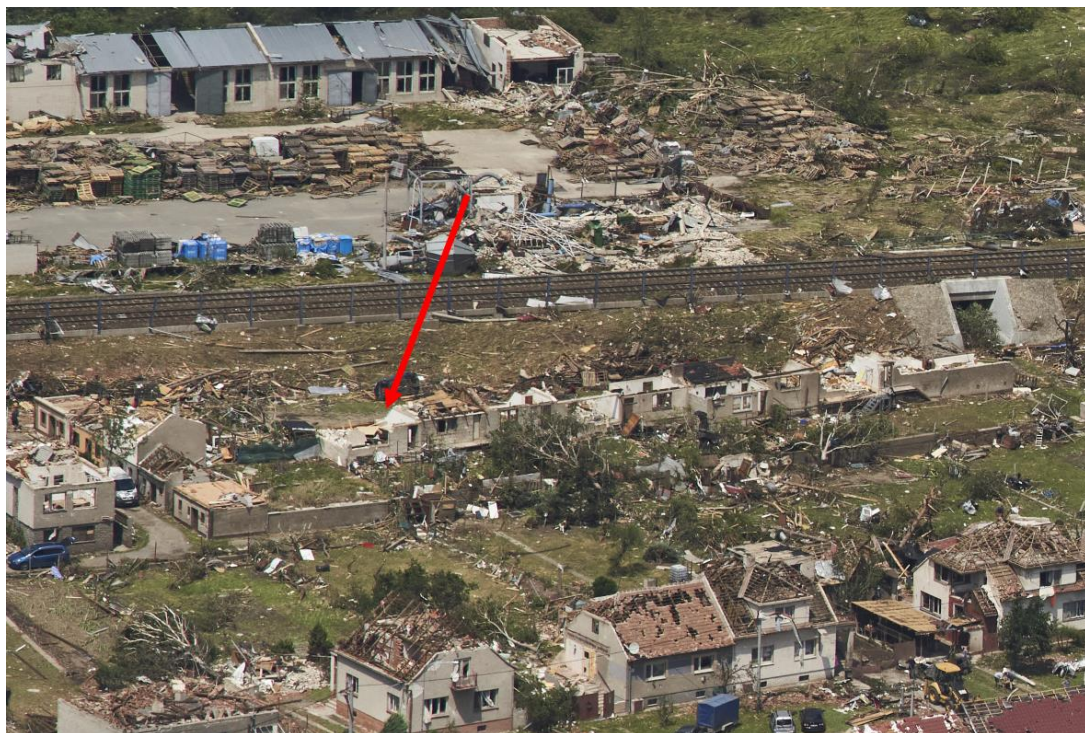
The most intense phase of the tornado occurred at the eastern end of Mikulčice where a narrow, 300 m long swath of IF4 damage was found as the tornado crossed the railway. Within the swath, several brick houses were destroyed. A bus with several passengers inside was thrown over a small hill, impacting a one-story high brick house. The first story of the house was completely destroyed, as well as two ground walls. Trees were debarked in the area and large concrete panels measuring 3 x 1 x 0.1 m were moved several meters. The railway was also badly damaged: Catenary along with large suspending pylons and railroad signals were

completely destroyed. Sound canceling barriers were destroyed as well, and the material from which they were made was scattered over large distances. The cross-section at this point shows a damage swath approximately 750 m wide with IF2 and stronger winds covering 250 m.

Aerial photo showing the beginning of the IF4 swath in eastern Mikulčice. Photo: Lukáš Ronge.

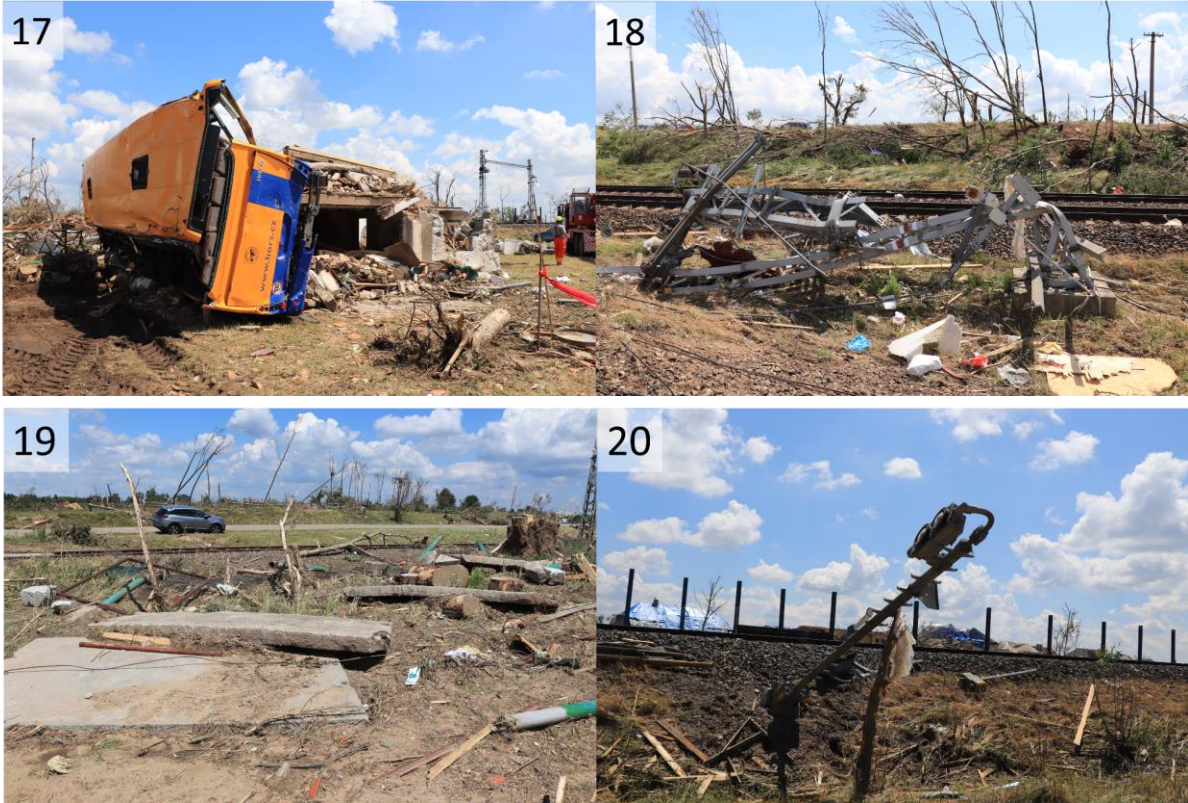
Photos showing damage in eastern Mikulčice. The Locations of photos 17 - 20 can be found on the map of Mikulčice. Author: Tomáš Púčik.

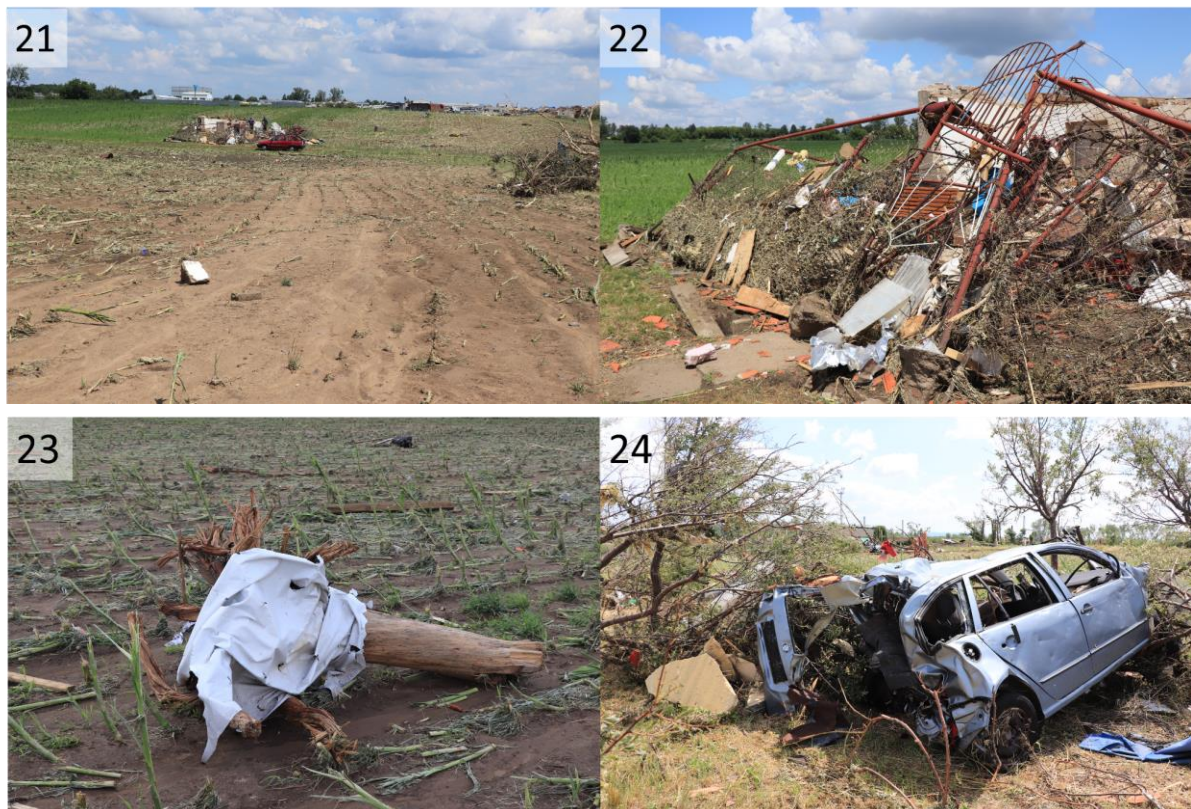
The tornado continued to become narrower as it moved towards Lužice, crossing fields and vineyards. Vineyards near the center of the tornado track were completely destroyed and iron wires used to hold the grapes were found mangled around trees. The center of the track was well visible as the tornado crossed corn field. Near the center, corn was reduced to several cm high stubs, with progressively less damaged towards the edges of the tornado path. The trees had been debranched or snapped and minor debarking was noted in some cases. Several smaller trees had been lifted by the tornado and thrown on the fields. Topsoil and crop/grass removal were observed in some segments. Several brick structures used as wine cellars had collapsed or had their brick walls damaged, but none of them was structurally sound enough to warrant an IF4 rating. The highest assigned rating to these structures was **IF3**. A layer of grass and mud was deposited on a bent fence surrounding one of the houses. A damaged vehicle was found in a field approximately 100 m away from the nearest road. Although the original location of the car is not known, its engine was found approximately 150 m away from the car in the opposite direction of the tornado's motion. Because no impact or drag marks were found in the field, it is likely that the car had been airborne for at least 200 m.

Photos showing damage between Mikulčice and Lužice. The locations of photos 21 - 23 can be found on the map of Mikulčice. The location of photo 24 can be found on the map of Lužice. Photos: Tomáš Púčik.

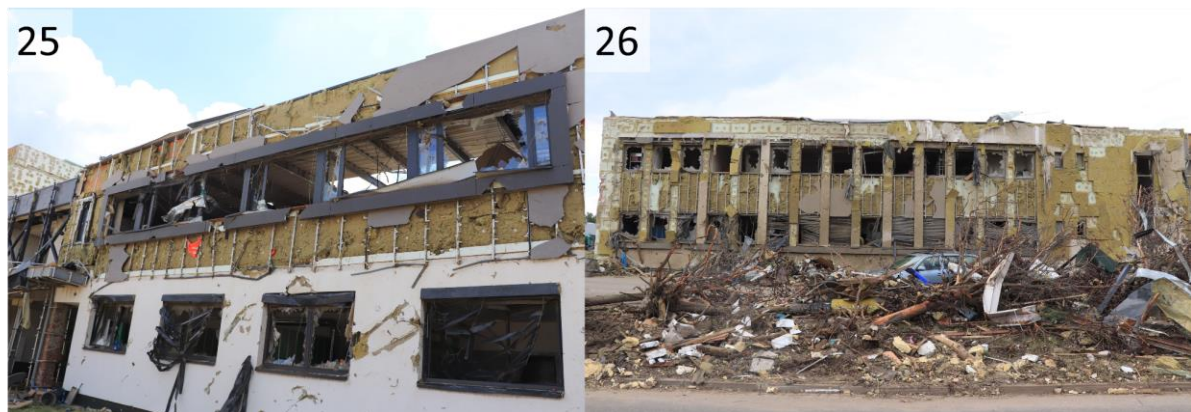
100 houses were damaged in Lužice, of which 17 had to be demolished. The tornado first impacted the industrial park of MND Drilling & Services and the Lužice train station. Well-built concrete or brick structures of the complex had significantly damaged roofs and facades, but their walls were mostly intact except where they had been impacted by heavy debris. A smaller, weaker-built brick structure had been completely destroyed, but was not sturdy enough to warrant an IF4 rating. Empty large containers were thrown by the tornado. A spot of intense damage occurred near one of the parking lots, where small trees had been debranched and debarked, and many cars had been thrown from the parking lot against the adjacent industrial building. The building was heavily damaged by the tornado and only steel pylons (some of them bent) were left standing. The ground survey team was not able to rate the damage to this building, but given the other damages at least **IF3** winds had occurred.

Photos showing damage in the industrial park in western Lužice. The locations of photos 25 - 26 can be found on the map of Lužice. Photos: Tomáš Půčík.

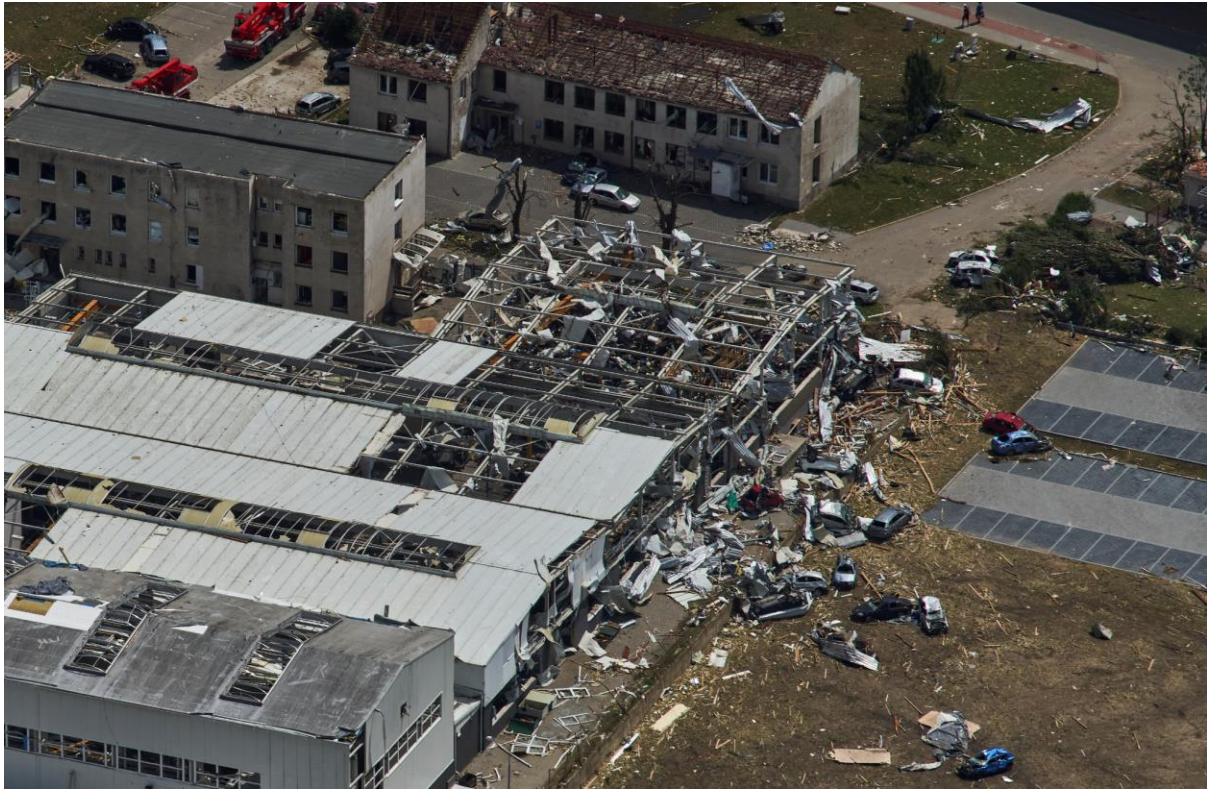
Aerial photo showing the displacement of cars from the parking lot in western Lužice. Photo: Lukáš Ronge.

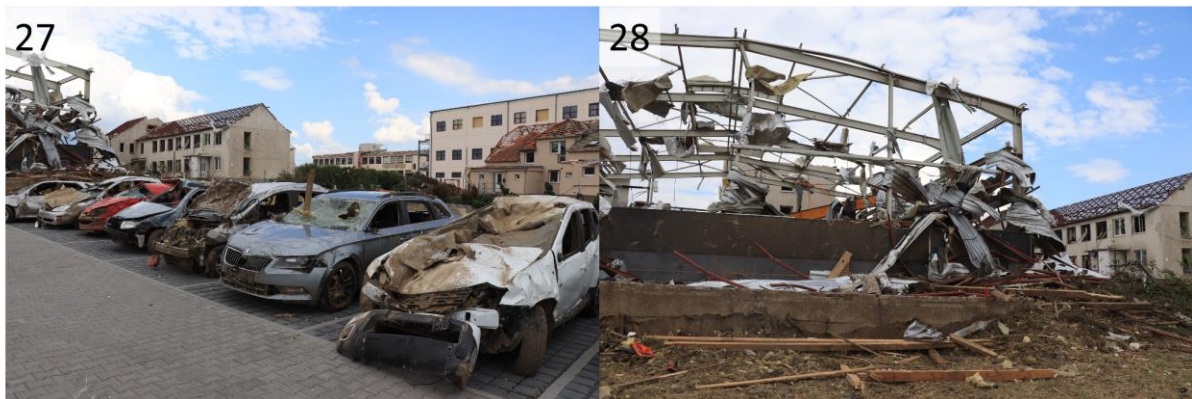
Photos showing damage in the industrial park in western Lužice. Cars were towed back from the field, where they originally landed. The locations of photos 27 - 28 can be found on the map of Lužice. Photos: Tomáš Půčík.

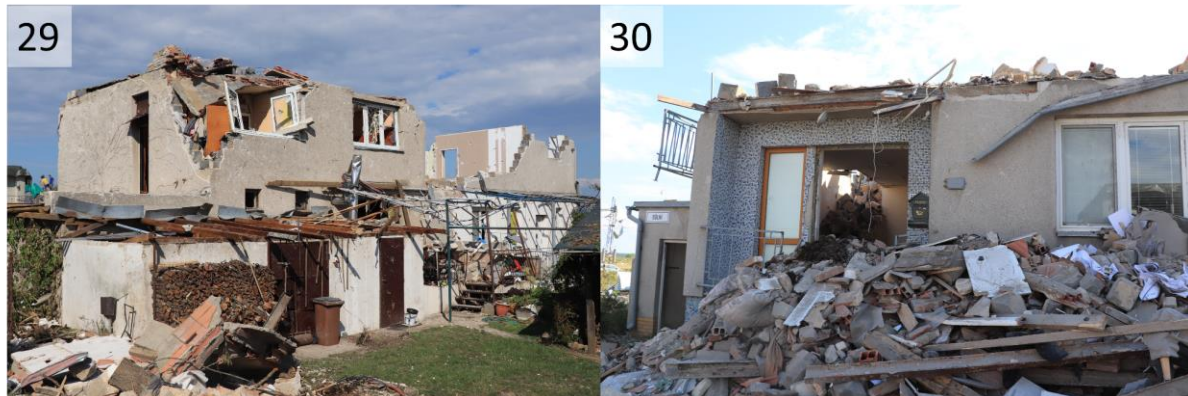
The tornado subsequently damaged houses along the main street, Velkomoravská, while crossing it. Several structures had brick walls damaged or destroyed, but were not sturdy enough to warrant a violent tornado (i.e. IF4) rating. The parallel orientation of the terraced housing of the street to the track of the tornado may have prevented more intense damage in this section as the strongest wind blew parallel to the long line of houses. The center of the tornado then moved over gardens south of the street, debranching trees and destroying some outbuildings. A more serious impact was surveyed at the southern edge of Důlní street. Two structures were heavily damaged by the tornado and were rated **IF4**. Both were very sturdy houses with thick brick walls. A debarked tree was also found behind the row of heavily

Photos showing damage in southern Lužice. The locations of photos 29 - 30 can be found on the map of Lužice. Photos: Tomáš Půčík.

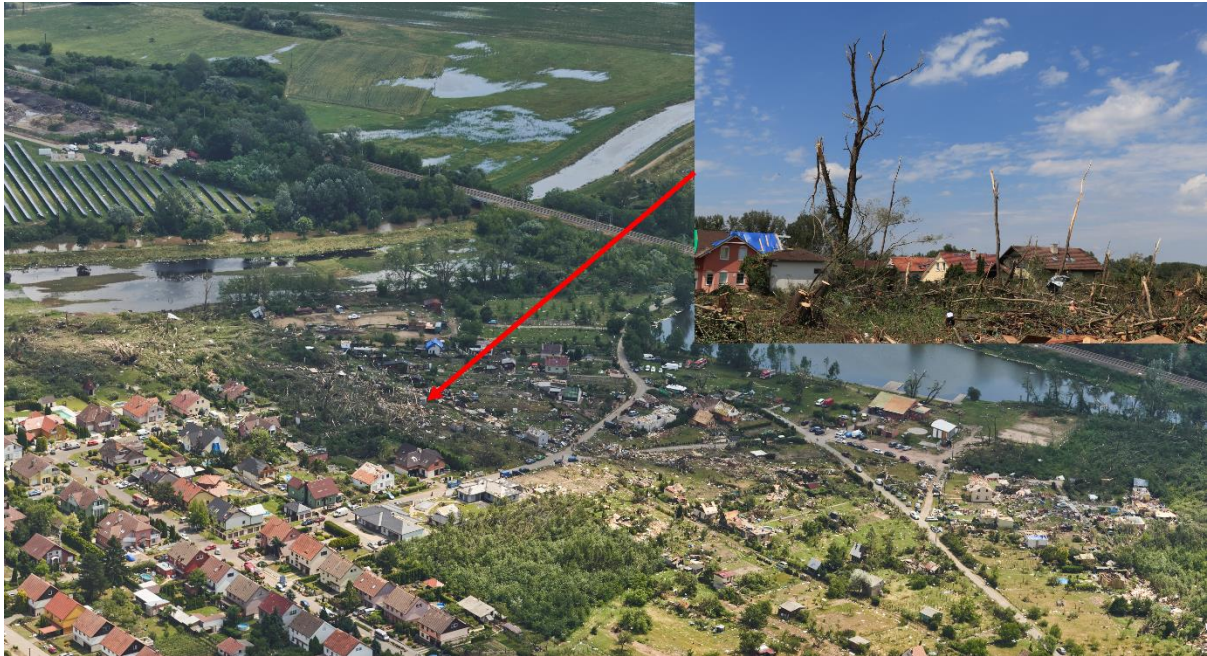
The tornado subsequently traveled across fields and gardens, destroying several small wooden or weaker brick structures. Debranching of trees and vegetation removal was noted in a 30 - 50 m wide swath. Near lake Lužák, several wooden and brick houses were completely destroyed. These destroyed structures were not permanent residences and thus were not of a high construction level. Stronger structures in the area suffered mostly roof damage. Extreme tree debranching was noted in a narrow swath 20 m across. Nearby houses located within 40 m only suffered minor roof damage. The highest damage rating in the area of lake Lužák was **IF3**.

Aerial and ground photos showing a narrow swath of significant damage to the forest in southeastern Lužice. Note only light damage to the houses within 40 m of the swath. Photos: Lukáš Ronge and Tomáš Půčik.

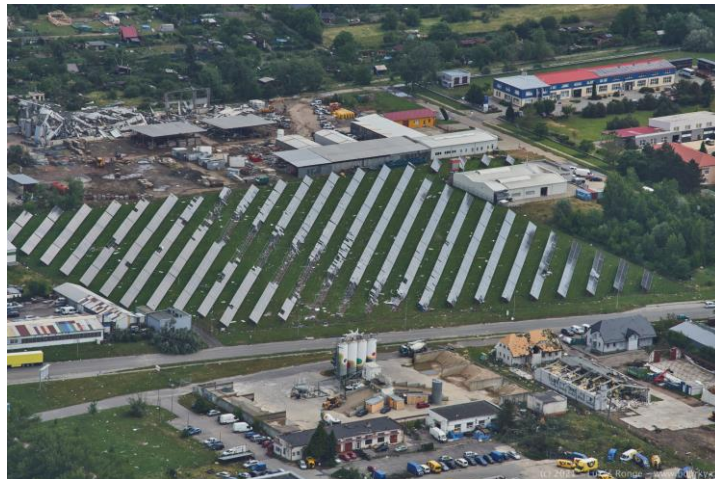
The tornado further narrowed as it travelled towards Hodonín and its path curved slightly northward. Sections of two solar power plants with photovoltaic panels were destroyed. A large metal storage building collapsed, and a weak brick structure was significantly damaged. Combined with minor debranching and snapping of trees, the damage here was rated IF2 in some locations of the tornado path. The tornado then moved over a gardening colony. Here, trees were snapped, and wooden outbuildings were destroyed by the tornado with a highest damage rating of **IF2**. The swath of strongly tornadic winds (i.e. at least IF2) was still narrow, measuring only 50 m.

Aerial photo showing damage to the photovoltaic panels east of Lužice. Photo: Lukáš Ronge.

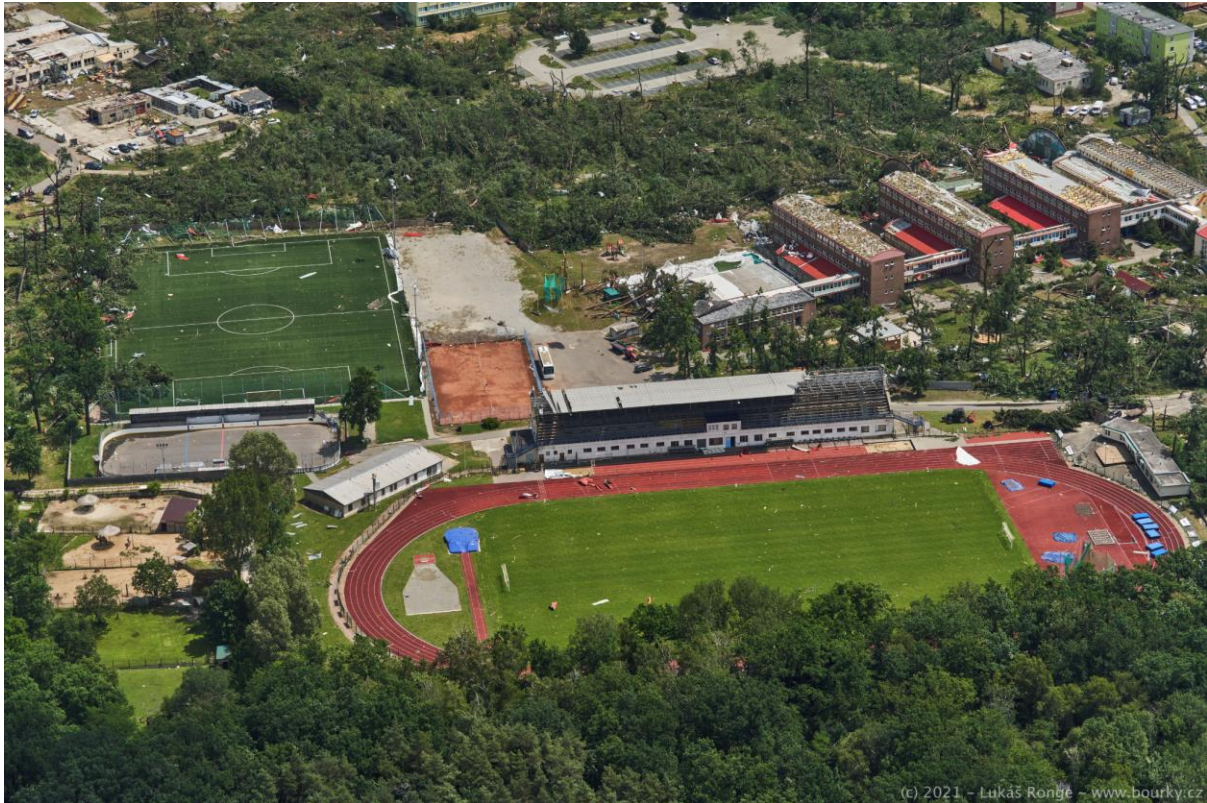
100 buildings were damaged in Hodonín (including Pánov, discussed later), of which 10 had to be demolished. Overall, the tornado was weaker in Hodonín than in the other settlements with a maximum assigned damage rating of **IF2**. The tornado affected the western outskirts of the town. The core of the tornado stayed mostly over the forest, preventing more building damage from the most intense part of the tornado. Had the tornado remained on its previous mean course between Hrušky and Lužice, it would have impacted the centre of the town.

Aerial photo showing damage gradient in Hodonín. Photo: Lukáš Ronge.

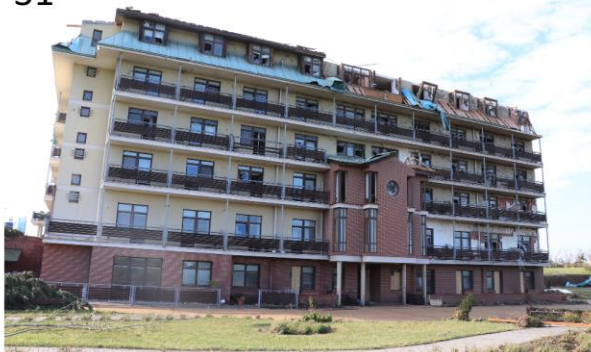
IF2 damage was observed in the forest where multiple trees snapped. Weak outbuildings were destroyed and the tornado partly impacted the local zoo. The local residential area Bažantice, consisting of large, 4-story high blocks of flats, was damaged by the tornado. The damage was mostly done to the roofs and was rated IF1, with the exception of an IF2 rating for the destroyed roof of a school. Several cars in parking lots were flipped. The tornado slightly grew in size as it crossed Hodonín. One of the most notable damage points in Hodonín was a home for the elderly, a large and multi-story building found at the northern edge of the town. Its roof and interior were significantly damaged, rendering the building unusable since the tornado. Wooden and steel beams from the roof were found impaled in the ground around the buildings and bent by the wind. Large concrete floor tiles were plucked out of the ground and thrown away.

Photos showing damage to the home for the elderly in northeastern Hodonín. The locations of photos 31 - 32 can be found on the map of Hodonín. Photo: Tomáš Púčik.

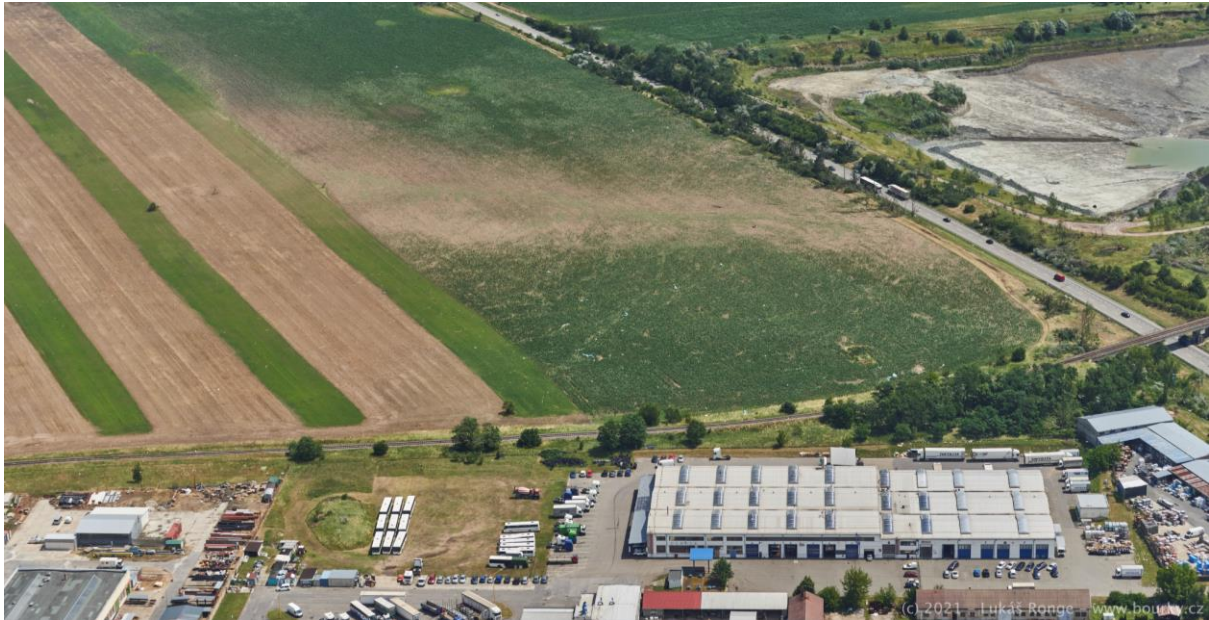
The tornado then crossed the road, field, and a forest between Hodonín and Pánov. Coniferous trees were mostly uprooted or snapped, while deciduous trees were sometimes partly debranched. High-voltage power lines were affected by the tornado with two pylons damaged. Just before Pánov, an edge of a photovoltaic power plant was damaged with many panels missing. The tornado then impacted the settlement Pánov. Sturdier-built houses suffered mostly roof damage. Several weaker brick walls collapsed in three smaller houses. By the time of the ground survey of this location (26 June, two days after the tornado), the structures had already been bulldozed down, preventing a precise assessment of their sturdiness. Taking into consideration the very conservative sturdiness rating and multiple wall failures, the resultant damage rating is **IF3**. The damage swath in Pánov was up to 600 m wide with winds of IF2 or stronger covering 100 m of the swath. The tornado finally moved over a forest, uprooting and snapping thousands of trees before decaying south of the village Ratíškovice.

Aerial photo showing the track of the tornado through the field northeast of Hodonín. Photo: Lukáš Ronge.
