Damage Survey of the Violent Tornado in Southeast Czechia on 24 June 2021

Tomáš Púčik
David Rýva
Miroslav Šinger
Miloslav Staněk
Pieter Groenemeijer

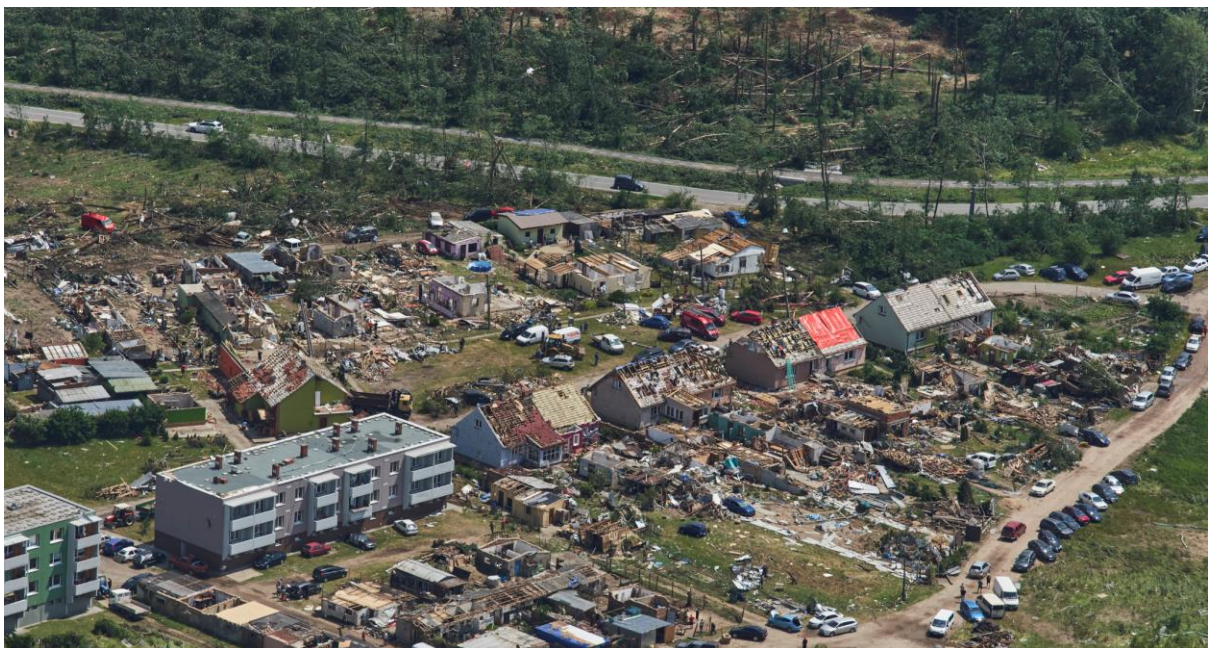
Aerial photo showing the damage in Pánov. Photo: Lukáš Ronge.

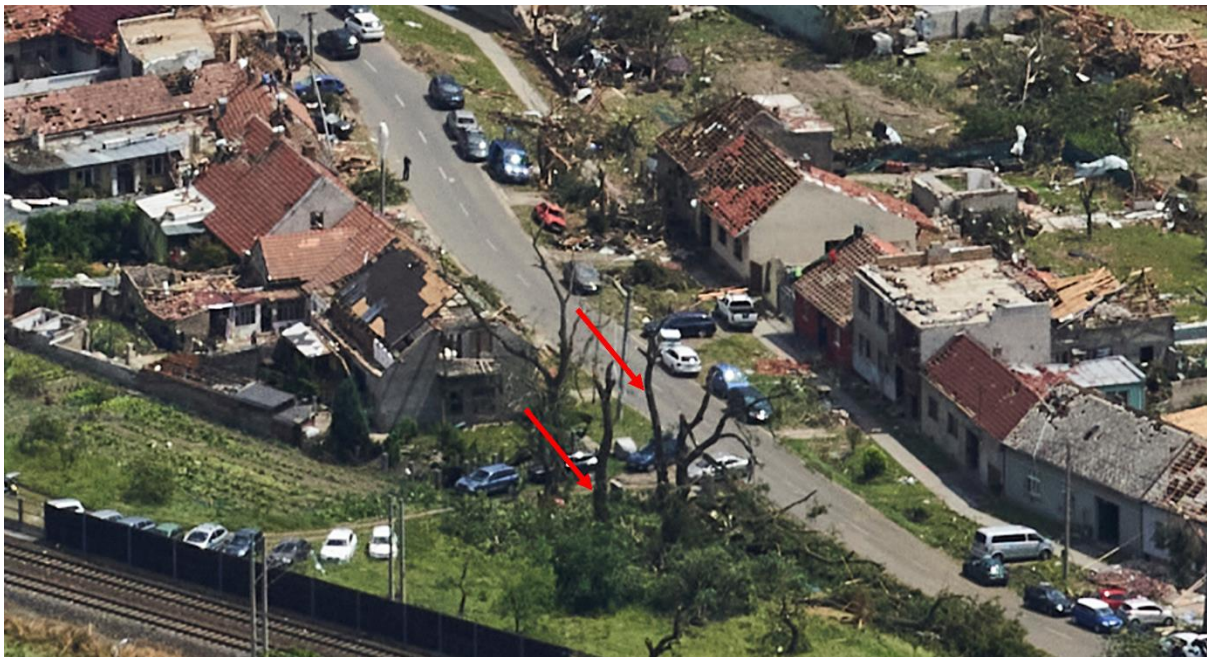
We found that high-end damage (IF3 - IF4) to buildings was very often accompanied by high-end damage to nearby trees. This high-end damage manifested itself as debranching and debarking. Debarking of trees happened when the nearby buildings suffered at least IF3 damage. In some cases, the damage rating from the vegetation exceeded that of nearby buildings. This occurred only with the damage indicator “debranching”. In the example shown in the figure below, two hardwood trees were significantly debranched, warranting an IF3 rating, while the surrounding houses show roof damage rated IF1 to IF2.

Aerial photo showing the vegetation and roof damage in western Mikulčice. Arrows point at the debranched trees with an IF3 damage rating. Photo: Lukáš Ronge.
