# FLASH FLASH PRODUCING STORM ON 23 MAY 2005 IN THE CZECH REPUBLIC

Milan Šálek<sup>1</sup>

<sup>1</sup>*Czech Hydrometeorological Institute, regional office Brno, Czech Republic, e-mail salek@chmi.cz*

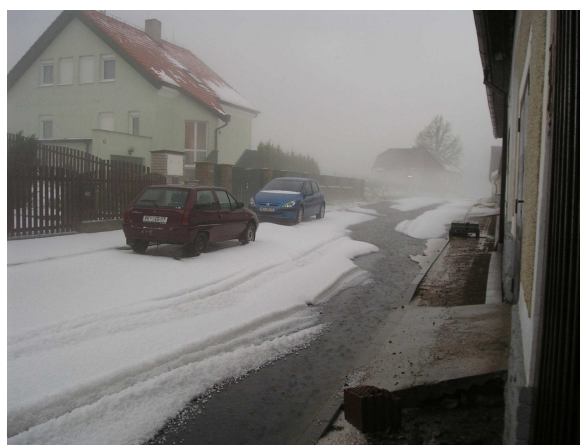
FIG. 3: Accumulation of hail in Kojčice on 23 May 2006

The convective storms caused especially heavy rainfalls and hail. The hailstones were only up to 2 cm in diameter but the hailfall was so intensive that the resulting hail depth was reported to be about 20-35 cm (Papež, 2005; see also Fig. 3).

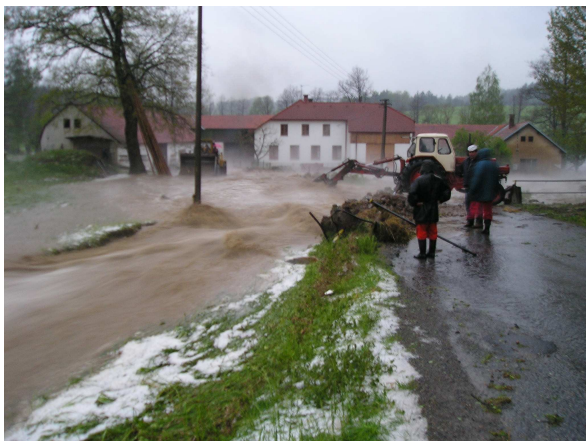
FIG. 4: Flash flood hitting Kojčice 23 May 2005, 18.27 UTC.

More significant outcome of the storm was heavy rainfall, which accumulated 171 mm of precipitation measured by raingauge. Resulting local flash flood hit Kojčice (Fig. 4), a rather small community of about 300 inhabitants. Several private and public properties were damaged, but no casualty was reported. The total damage cost in Kojčice reached 300 000 Euro.
