ESSL IF-Scale Tornado Summary

Tornado from Lichtenvoorde to before Genderen/Tubbergen, Netherlands - 1927

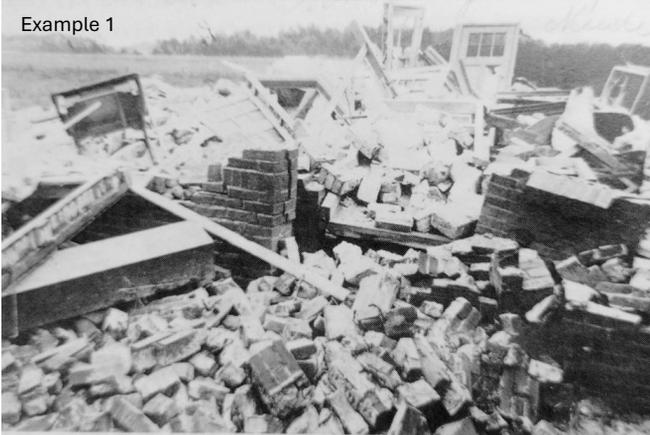
Example 1

These examples show two residential buildings close to each other that have been completely destroyed (DoD2). Wall thickness in the first example is typical for this type of building, while wall thickness in the second example cannot be estimated, since the building was completely reduced to piles of bricks.

An important fact is that the house in example 1 was only 3 months old and therefore likely in good condition.

IF-Scale damage indicator (DI): BS (building, structural elements)

IF-Scale sturdiness class: E

IF-Scale Degree of Damage (DoD): 2

(more than 2/3 destroyed)

IF-Scale result: IF5

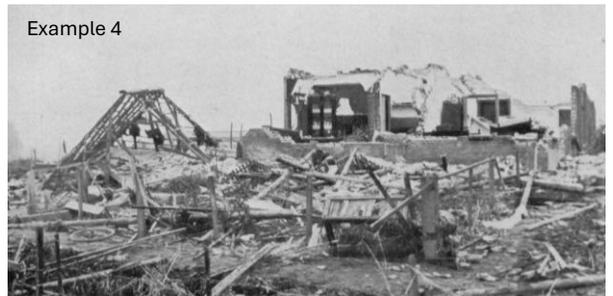
Example 4

These are examples of buildings that were badly damaged too, but where intensity was considered to have been less than IF5.
