ESSL IF-Scale Tornado Summary

Tornado from Volpago del Montello to Nervesa della Battaglia, Italy

24 July 1930, 11:16 UTC

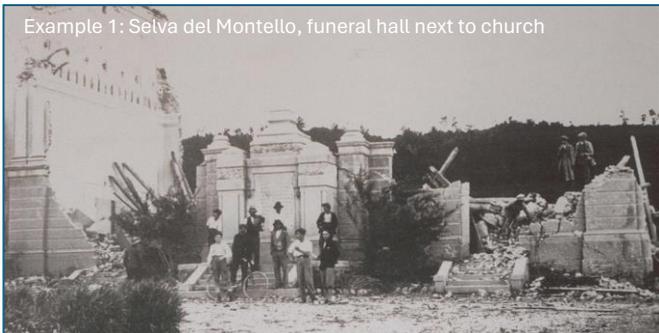
Example 1: Selva del Montello, funeral hall next to church

The most prominent damage was found next to the severely damaged church of Selva del Montello. While for the church the assumption of a problematic geometry of the collapsed nave led to an IF4 rating (BS E, DoD 1B), this does not hold for the neighboring funeral hall ("La Sala Votiva") that has been completely destroyed. A photo from the remaining "interior" part (not shown) revealed a wall thickness of 40 – 80 cm (BS E or F, depending on "weak" or "strong" quality of mortar and bricks, which is unknown). With nearly total destruction (DoD 2), both options for BS lead to IF5.

IF-Scale damage indicator (DI): BS (building, structural elements)

IF-Scale sturdiness class: E or F

IF-Scale Degree of Damage (DoD): 2

(Near complete destruction, more than 2/3)

Result for sturdiness class E: IF5

Result for sturdiness class F: IF5

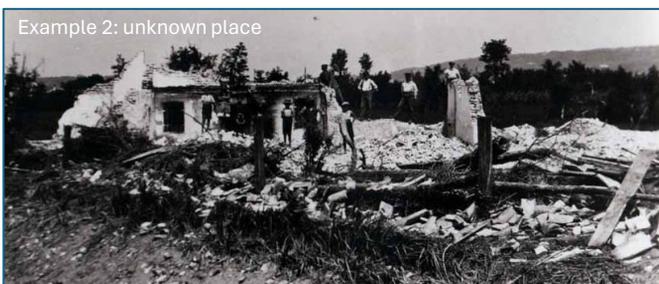
Example 2: unknown place

The exact dimensions of the building before destruction are unknown in this case. We estimate the width of the load-bearing walls to be around 40 cm by comparison with closeby persons. BS E is a middle choice between BS D (wall thickness less than 40 cm and weak quality) and BS F (wall thickness larger than 40 cm and strong quality of bricks and mortar) estimates. The degree of damage is clearly larger than 2/3, i.e. falls into DoD 2.

DI: BS E

DoD: 2

IF-Scale result: IF5
