# **Towards an improved wind speed scale vs. damage description adapted for Central Europe**

**5th ECSS Special Issue**

## Abstract

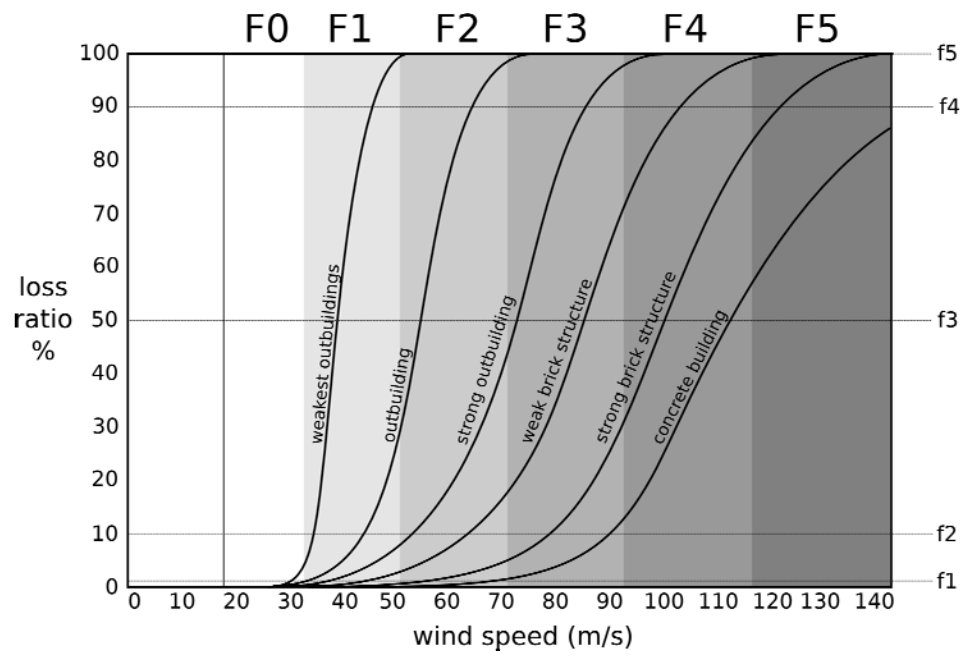
1  
2 Fig. 1: The f-scale decision matrix for building structures adapted for Central Europe. The  
3 numbers in italics refer to the damage photographs in Sec. 3.

Fig. 1 shows the relation between damage (f) and wind speed (F) in form of an f-scale decision matrix like that originally proposed by Fujita (1992). Here, we include six different building types as DI typical for Central Europe when determining tornado or downburst intensity. This concept does not take into account a variety of DI as large as in the EF-scale currently used in the USA. However, this facilitates to relate the degrees of damage (DOD) noted verbally on the abscissa to loss ratios

Fig. 1 translates to a set of six loss ratio curves as shown in Fig. 2. For each curve, the strongest absolute increase in  $L$  occurs in a narrow range of wind speed. This reflects a maximum breakdown probability of structures around a specific critical destructive wind speed. It is however important to realize that at much lower wind speeds, especially when they occur over large areas, high amounts of accumulated damage may occur. These are signified by high claim ratios, even though loss ratios may still be below 1%, as described in Heneka and Ruck (2008). Experience shows that a loss ratio of 1% is a threshold of substantial building damage.

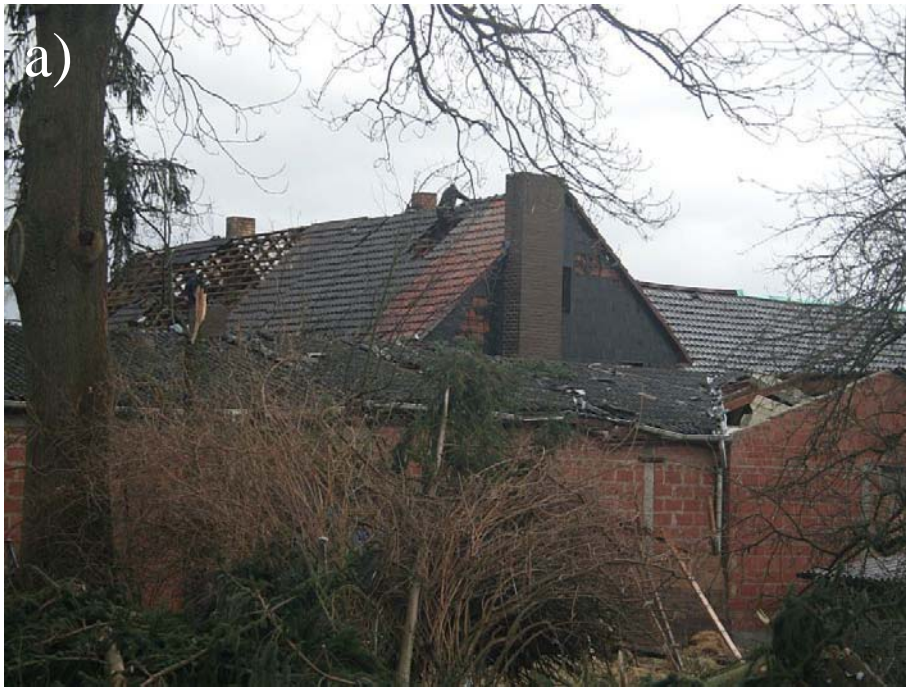
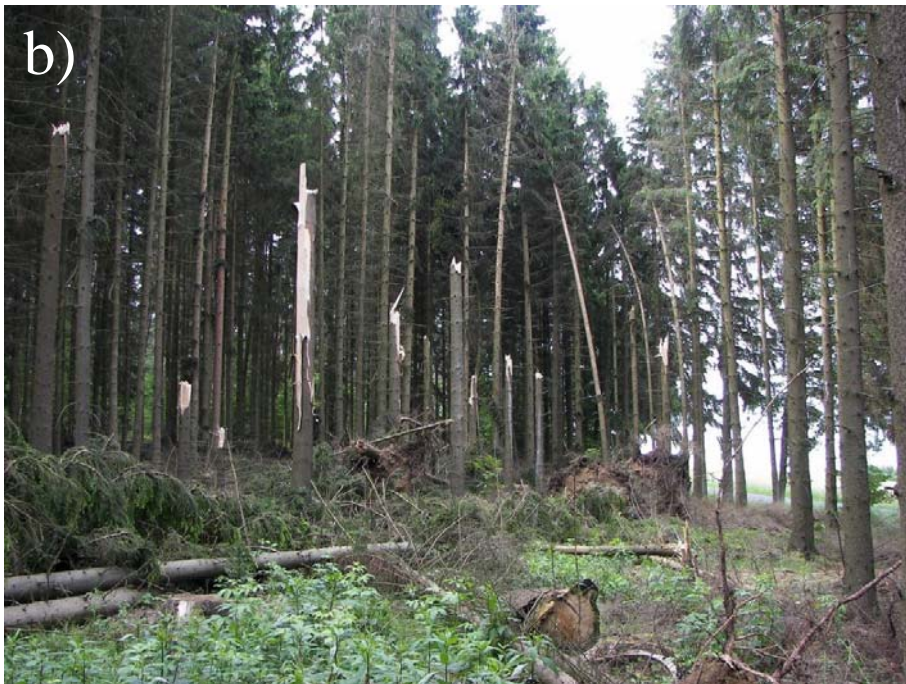
Fig. 8: T2 (F1–) damage. (a): Roof partially untiled. Downburst, 17 January 2007, Melle-  
Riemsloh (Germany), Photo: Martin Hubrig. (b): Permanently bent spruces. Downburst, 6  
June 1998, Steinfurt (Germany), Photo: Martin Hubrig.

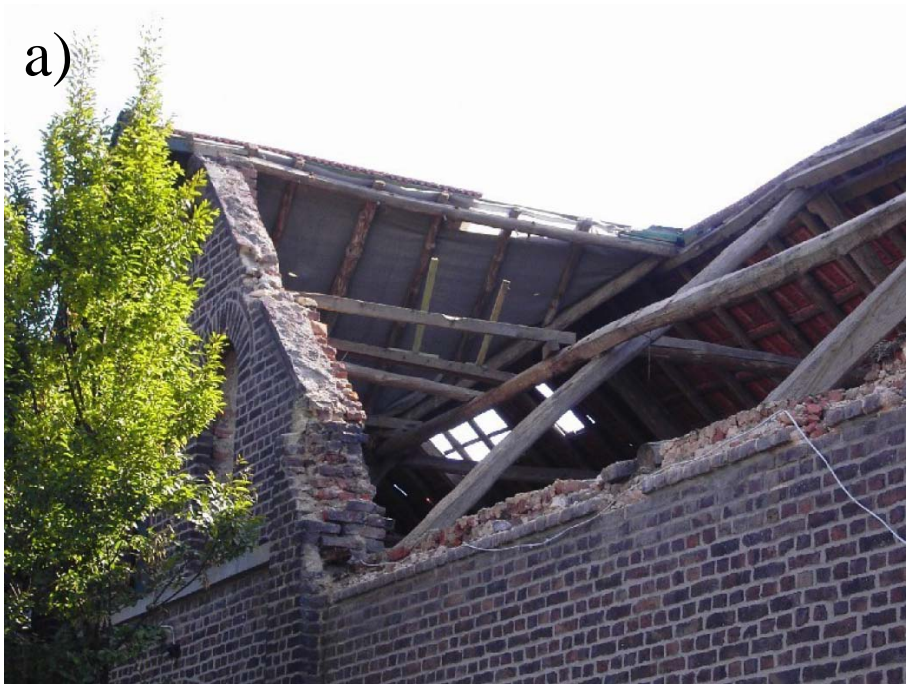
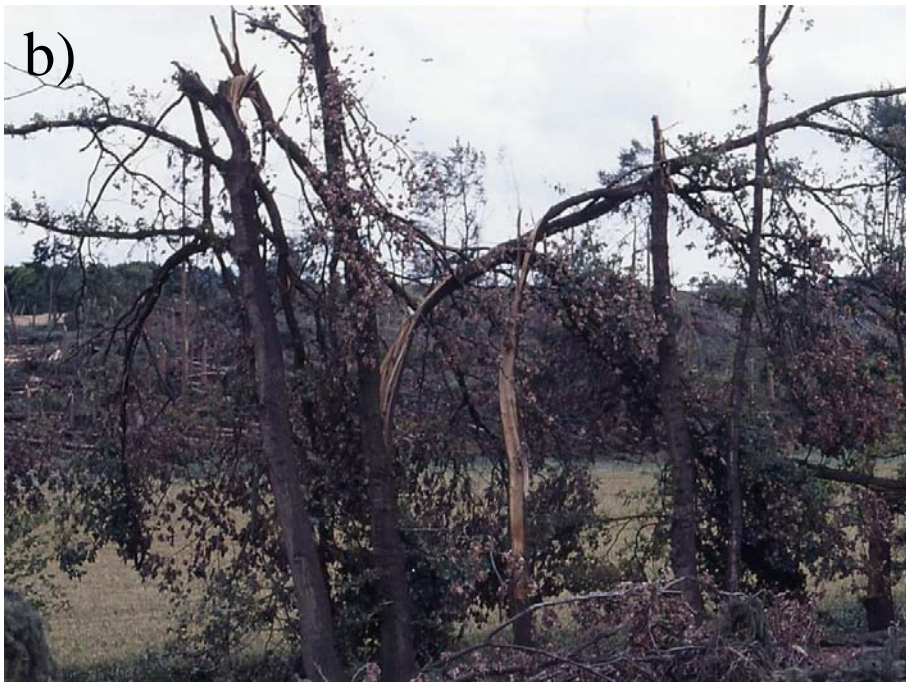
Fig. 10: T4 (F2–) damage. (a): Barn ruined, Photo: Erik Dirksen. (b): Swath in beech forest with remaining edge trees, Photo: Bernhard Pohl. Both panels from tornado, 13 May 2007, Kall-Sistig (Germany).

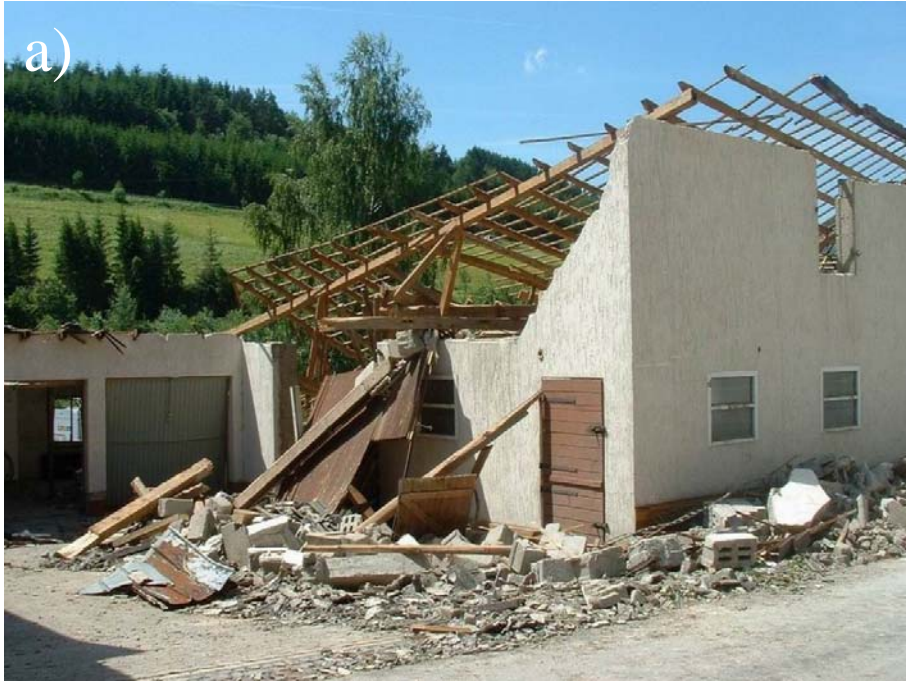
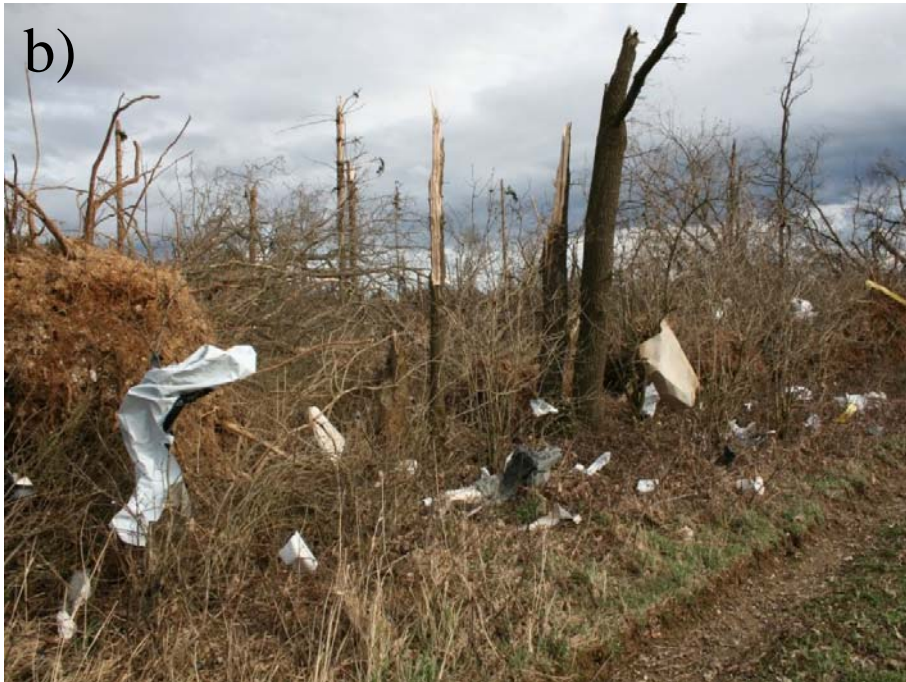
Fig. 11: T5 (F2+) damage. (a): Aged roof structure partly destroyed. Tornado, 18 July 2004, Tönisvorst (Germany), Photo: Thomas Sävert. (b): Heavily damaged edge trees. Tornado, 29 June 1997, Bissendorf (Germany), Photo: Martin Hubrig.

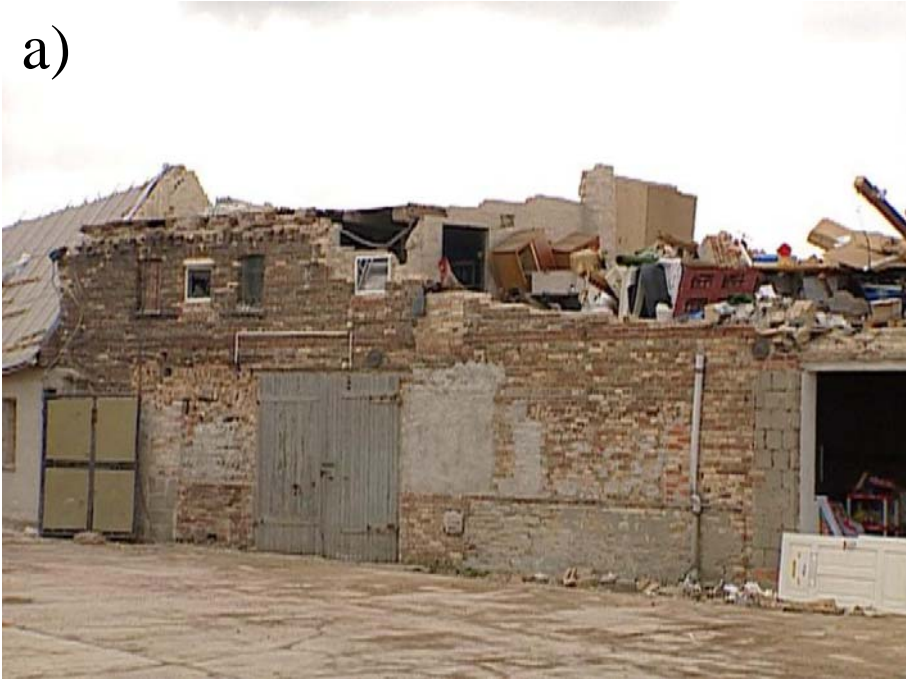
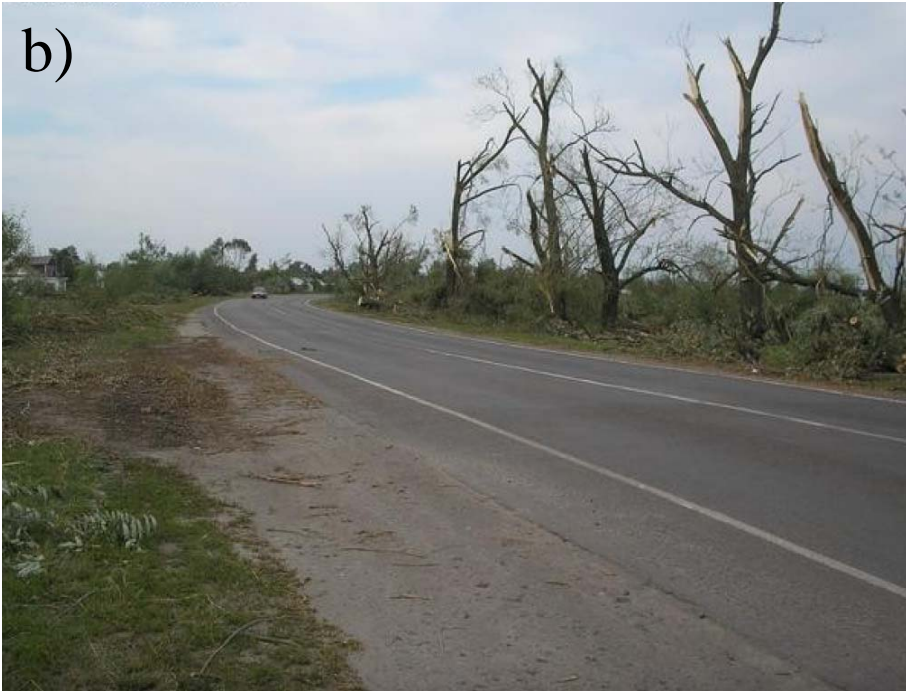
Fig. 12: T6 (F3–) damage. (a): Largely demolished and partly collapsed outbuilding. Tornado, 10 June 2003, Acht (Germany), Photo: Matthias Habel. (b): Completely destroyed sturdy but exposed forest edge. Downburst, 1 March 2008, Braunau am Inn (Austria), Photo: Alois M. Holzer.

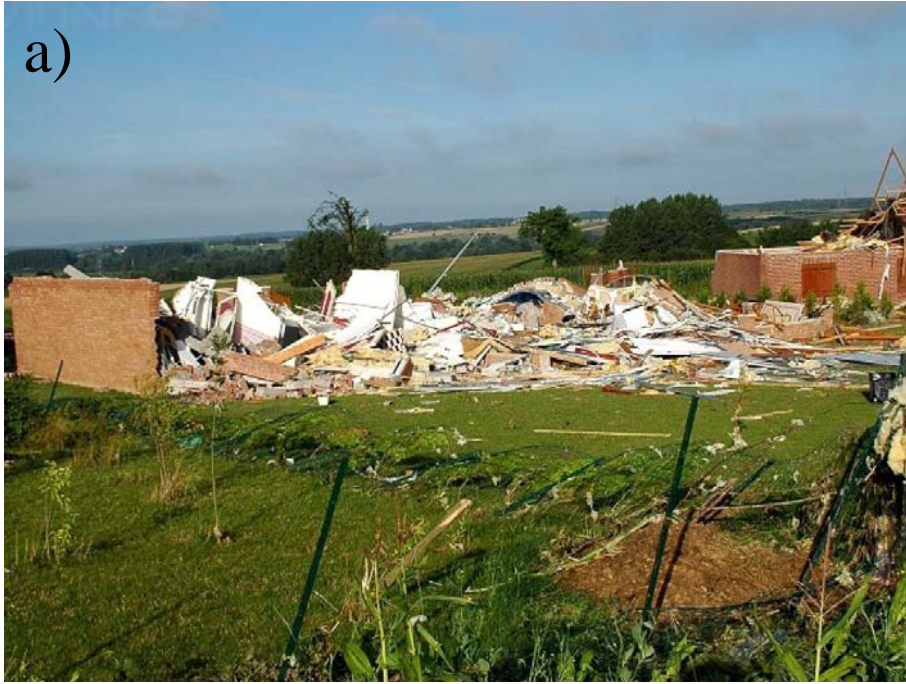
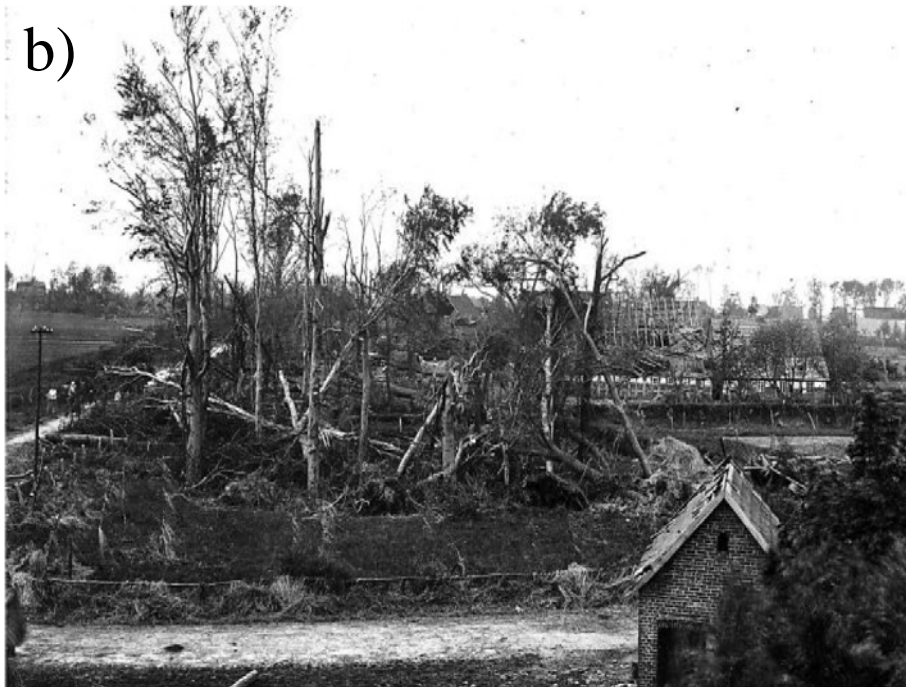
Fig. 13: T7 (F3+) damage. (a): Upper storey of outbuilding completely destroyed. Tornado, 23 June 2004, Micheln (Germany), Photo: Martin Hubrig. (b): Destroyed solitaire trees with isolated debarking. Tornado, 22 July 2007, Turiysk (Ukraine), Photo: Olexandr Khilchuk.

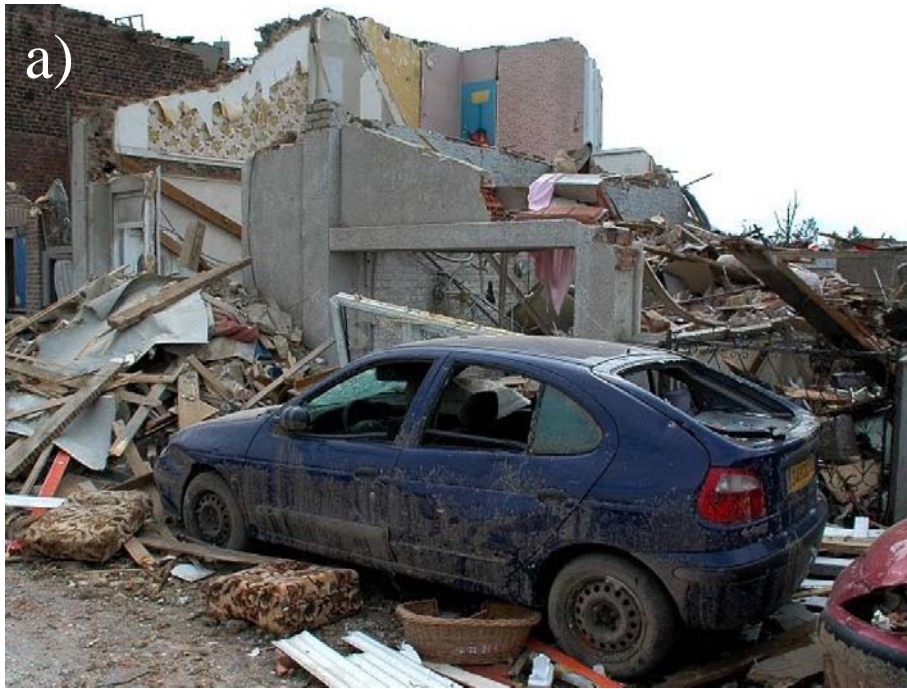
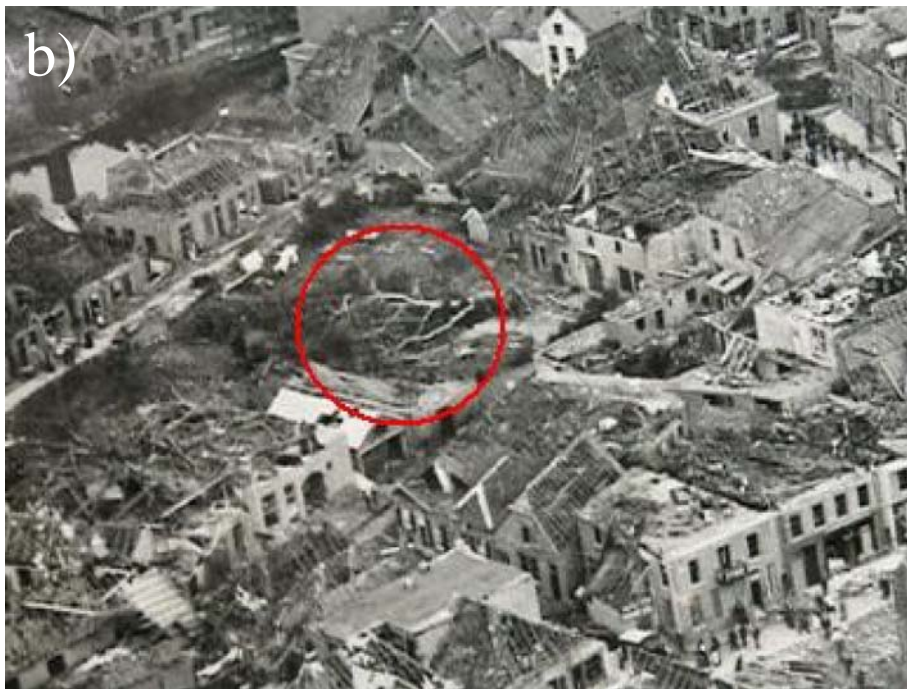
Fig. 14: T8 (F4–) damage. (a): Prefabricate house with brick facing blown down. Tornado, 3 August 2008, Hautmont (France), Photo: Bjoern Stumpf. (b): Ruined beech trees with distinct partial debarking. Tornado, 1 June 1927, Auen (Germany), Photo: Heinz Brinkmann.

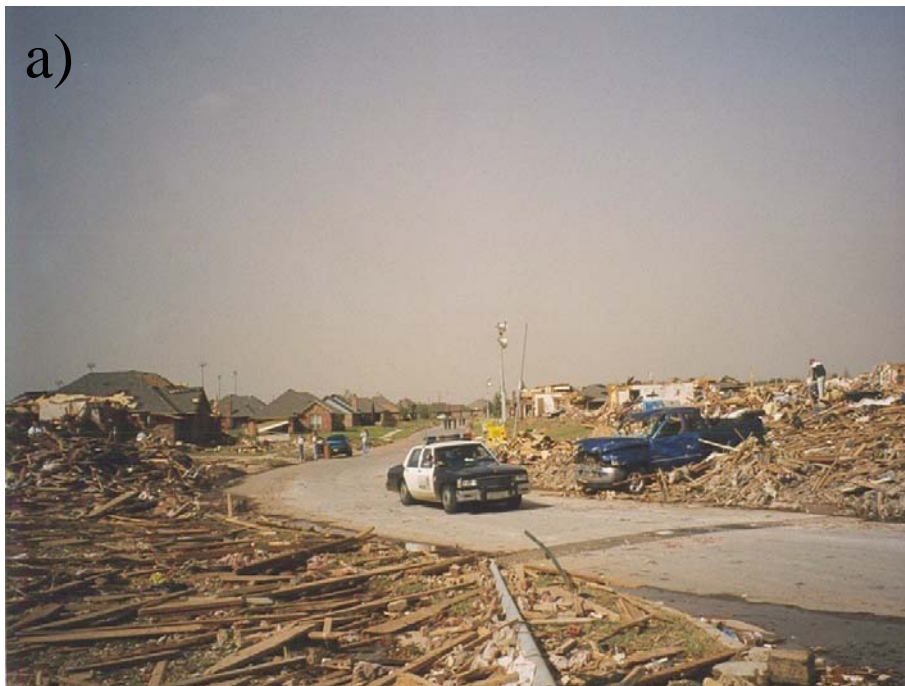
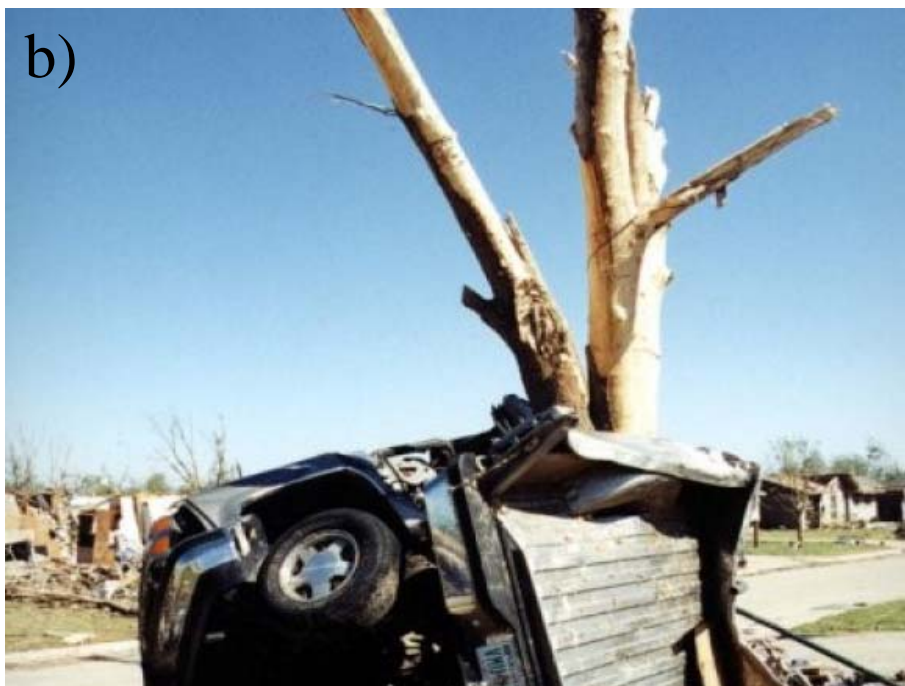
Fig. 15: T9 (F4+) damage. (a): Massive (brick) house ruined down to base walls. Tornado, 3 August 2008, Hautmont (France), Photo: Bjoern Stumpf. (b): Largely debarked Tree. Tornado, 10 August 1925, Borculo (Netherlands), Photo: Stormrampmuseum Borculo.

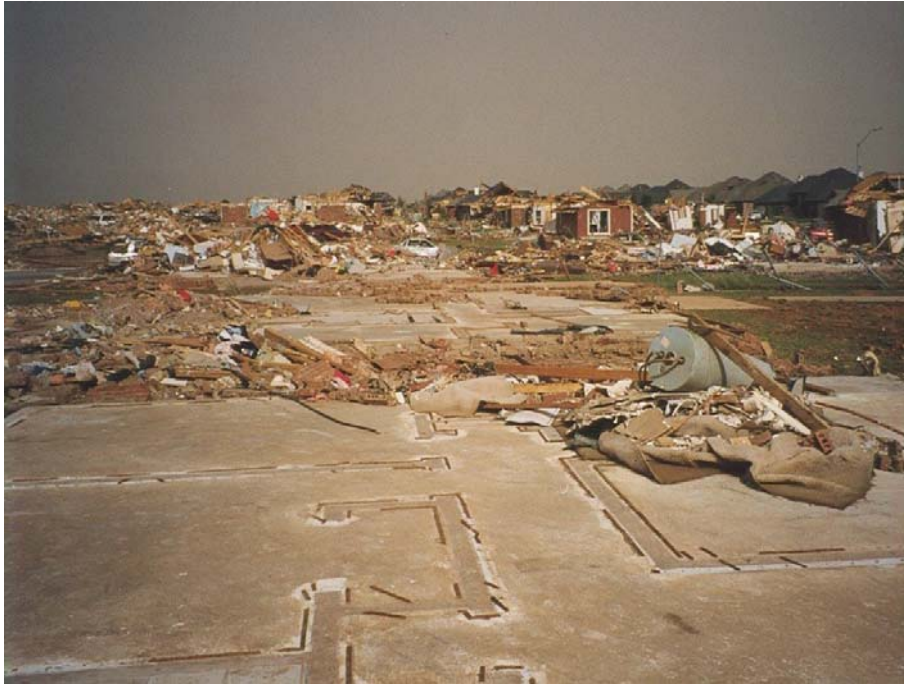
Fig. 16: T10/11 (F5) damage. (a): Complete destruction (total loss) of buildings. Tornado, 3 May 1999, Moore, OK (USA), Photo: Mike Branick, NWSFO. (b): Widely debarked tree and destroyed pickup truck. Tornado, 3 May 1999, Moore, OK (USA), Photo: Kevin Kelleher.

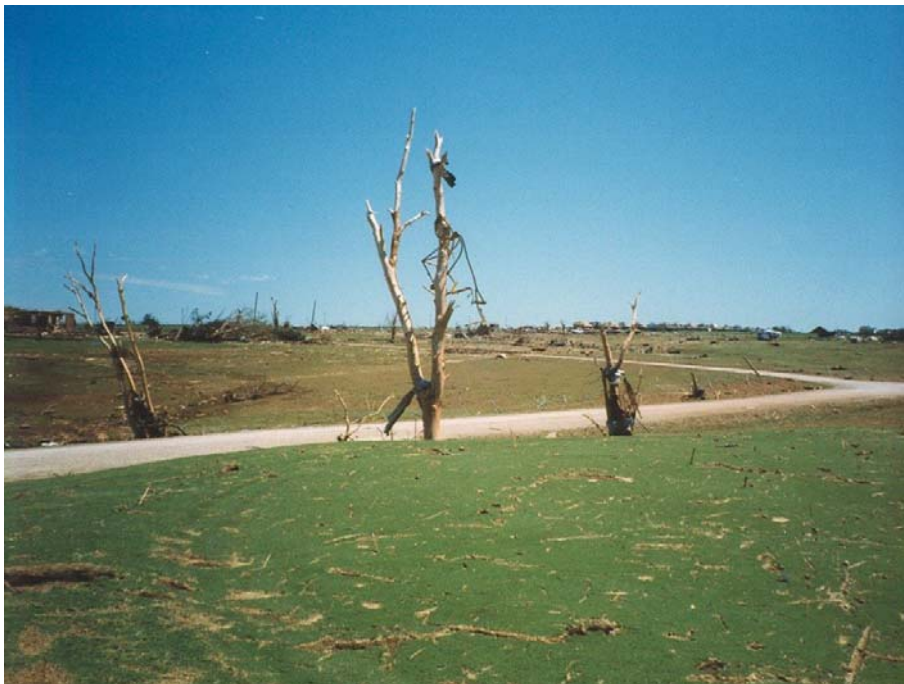
3 Fig. 17: T10/11 (F5) damage. (a): Buildings blown away from foundation. Both panels  
4 tornado, 3 May 1999, Moore, OK (USA), Photos: Mike Branick, NWSFO. (b): Completely  
5 debarked solitaire tree ruins.
